# EXISTING SITE CONDITIONS

## CAPRI ELEMENTARY

Encinitas Union School District  
Facilities Plan Update

941 Capri Rd, Encinitas, CA 92024

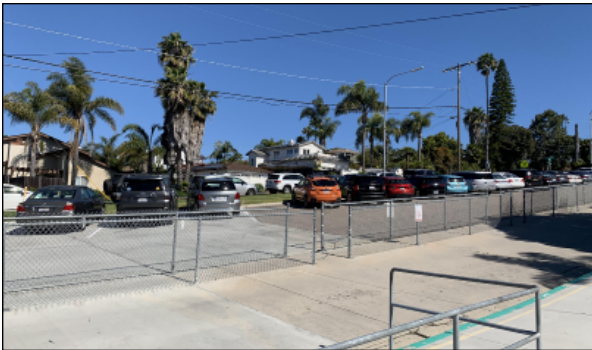
Drop-off Loop

- Main drop-off at North edge of site is a confined area, making vehicular/pedestrian traffic more difficult.
- There is currently a lack of covered area for

students to wait for parents to pickup during inclement weather, and congestion on regular basis

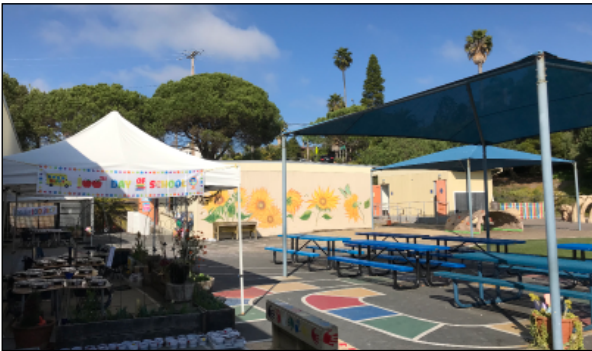
Kindergarten Play Area

- The Kindergarten play equipment was replaced in Spring 2016 and is in good condition. Rubberized surfacing is at this location.
- Play equipment for the remaining grades is

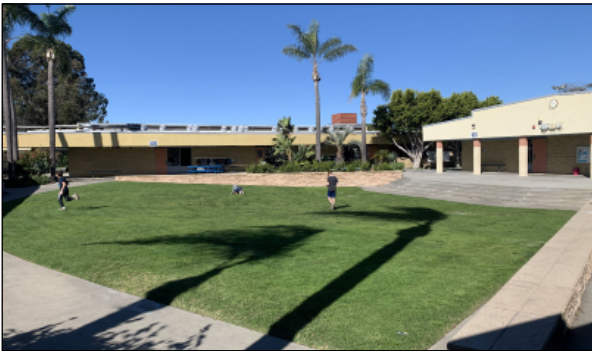
Campus Quad

- Lunch shelter acoustics are not ideal, recommend addressing this in future work.
- Existing shade sails provide shade between classroom buildings at main level of campus.
- Track is DG/grass - replace with rubberized surfacing.
- Dedicated outdoor learning spaces would be ideal.
- Quad in center of campus is well-utilized - ideally, but could be improved with more intentional outdoor learning environment

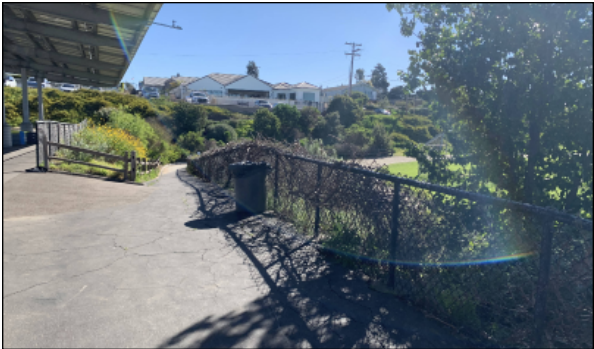
Access to Playfields

- Path of travel compliance needs to be evaluated. The ramps leading to the lower field area appear to have a non-compliant slope and should be replaced with compliant ramp runs. An additional egress ramp should be added so as to not create a bottle neck in an emergency condition
- Restrooms have had ADA upgrades.
- Classroom sinks and casework have had ADA

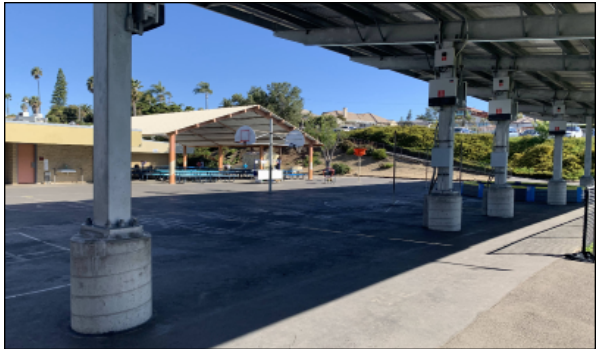
Shade Structure with Lunch Shelter in background

- Concrete paving is in good condition throughout campus.
- Concrete paving at lunch shelter is very difficult to clean/maintain. Recommend replacing this hardscape in future site work scope.

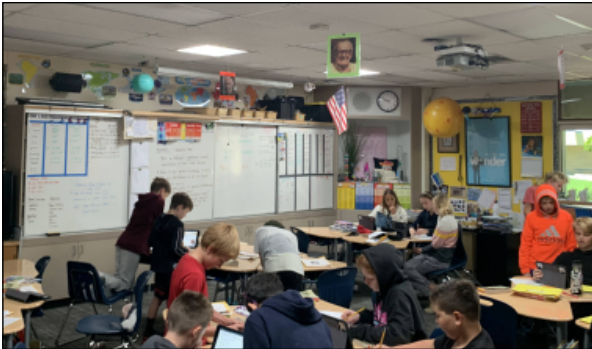
Typical Classroom

- In general, the interior finishes (flooring, painting and whiteboards) are in good condition.
- Carpet was replaced throughout campus in 2019.
- Casework is in acceptable condition but could use an update.
- Classroom ceilings are mostly ACT - tiles appear to be dated and in fair condition, recommend replacing these as classrooms are updated in future work.
- The Administration, and MPR buildings also have aged ACT ceilings and future replacement is recommended.
- The Media Center and Science Room have ACT ceilings that were recently replaced and are in good condition.

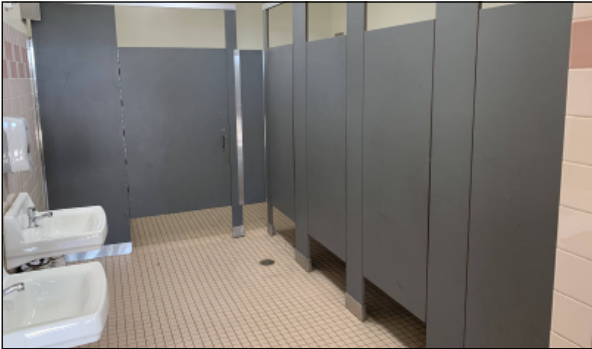
Typical Student Restroom

- Plumbing piping is understood to be original to the 1969 construction and should be replaced.
- Typical student and staff restrooms appear to have had ADA upgrades and meet accessible codes of that time. Due to code changes they will most likely need some upgrades if future work is to be done at existing buildings.
