# EXISTING SITE CONDITIONS

## MISSION ESTANCIA ELEMENTARY

Encinitas Union School District  
Facilities Plan Update

3330 Calle Barcelona, Carlsbad, CA 92009

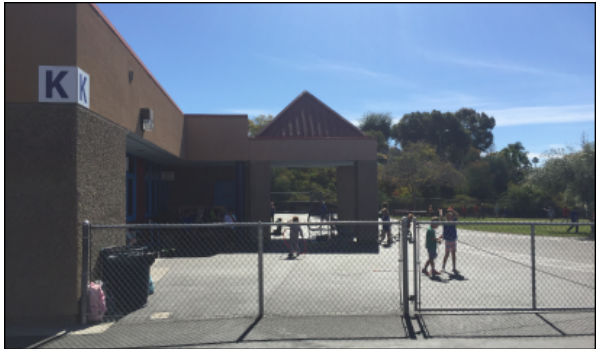
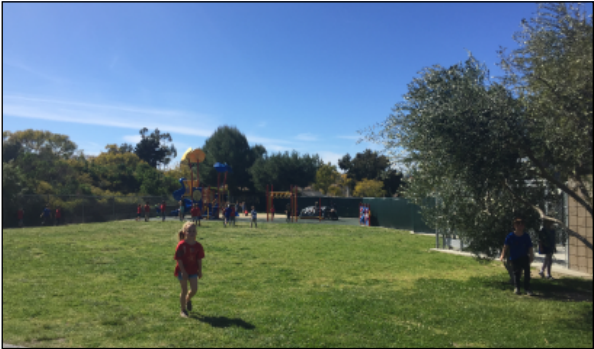
Kindergarten Play Area

- The main play equipment north of shade structure is in fair condition.
- Replace fiber chips in fall zone with rubberized surfacing.
- Ball wall is in good condition.
- Swings are in good condition, replace fiber chips with rubber.
- Basketball goals and posts are in good condition.
- Baseball infield areas should be removed or re-worked. Potential replacement of backstops.

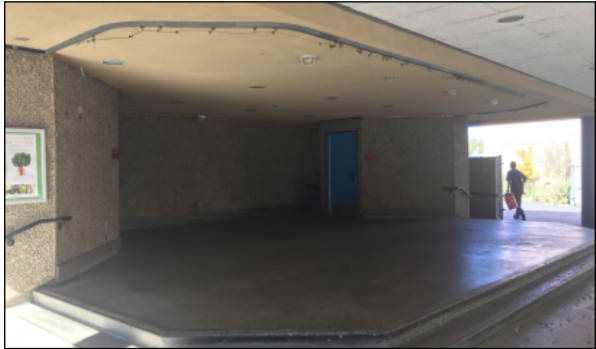
Outdoor Stage

- Improve existing exterior open-air MPR structure.
- Track is DG/grass - Replace with rubberized surfacing.
- Dedicated outdoor learning spaces were requested.

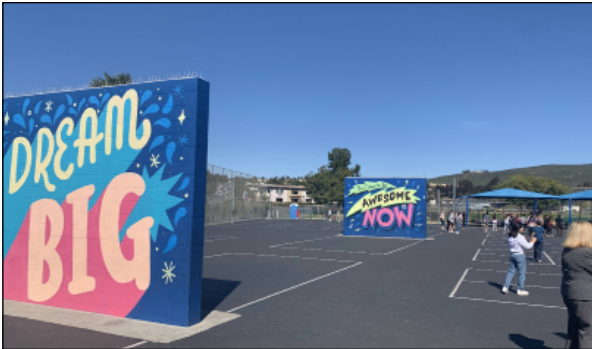
Hardcourts

- Hardcourt striping and patching was recently completed.
- Recommend decreasing the amount of AC paving and converting these areas to planted areas and outdoor classroom space.

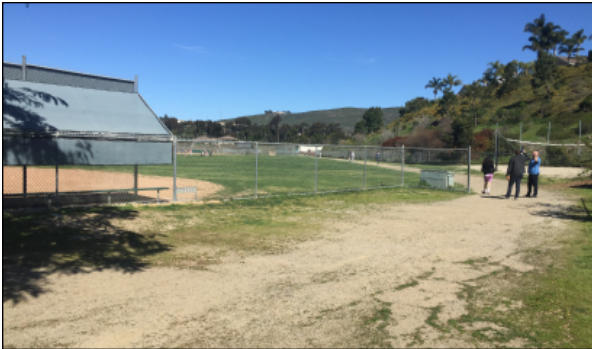
Playfields

- Grass areas should be reseeded and regraded.
- Desire for landscape areas to be upgraded to drought tolerant plants.
- More shade trees are recommended throughout campus.

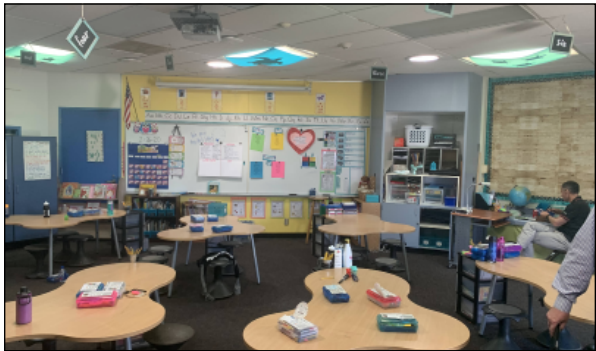
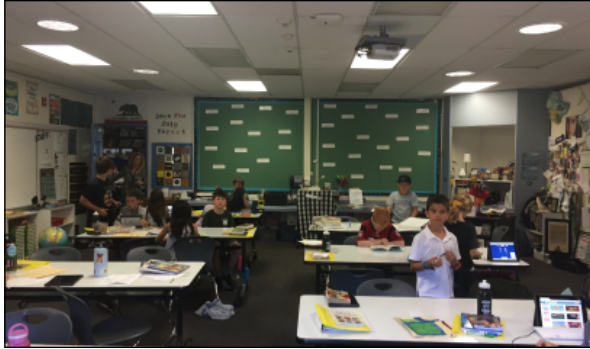
Typical Classroom

- In general, the interior finishes (flooring, painting and whiteboards) are dated and could use an update.
- Casework is in acceptable condition but could use an update.
- Classroom ceilings are ACT-type; tiles are dated or damaged and should be replaced when future work is completed in these areas.
- The interior MPR is not an enclosed space and is used as a pass-thru for students and staff. Recommend closing off this space in future work to alleviate the acoustical issue.

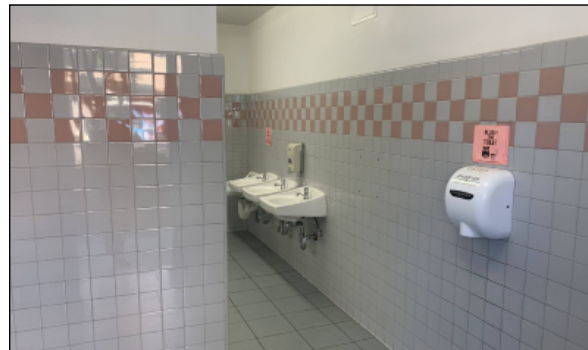
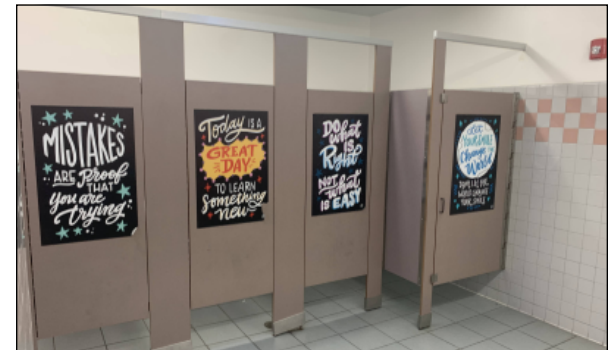
Typical Student Restroom

- Category [0.5]
- Plumbing piping appear to be original to the 1990 construction and there are no known issues.
  - Typical student and staff restrooms appear to have had ADA upgrades and meet accessible codes of that time. Due to code changes they will most likely need some upgrades if future work is to be done at existing buildings.
