## EXISTING SITE CONDITIONS

### DISTRICT OFFICE

Encinitas Union School District  
Facilities Plan Update

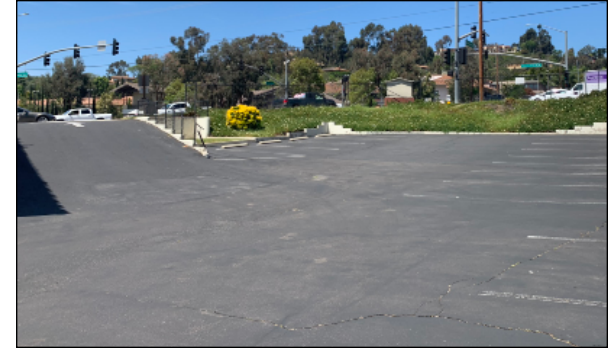
North Parking Area

- Parking is located at the North/NW corner of the site, and is constrained to this area. Capacity would ideally be increased if there was additional site area to expand into.

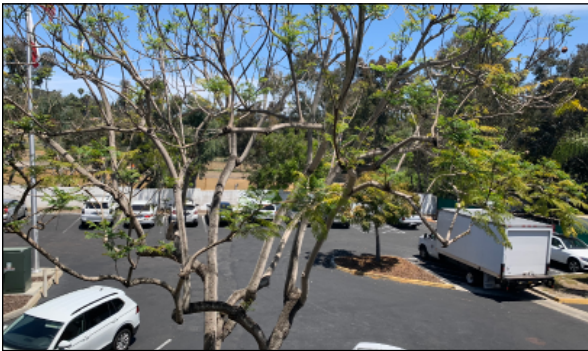
Main Parking Area

- The parking area was repaired, resealed and re-striped during Summer 2020.
- Verify potential cross slope issues (>2%) in future work.

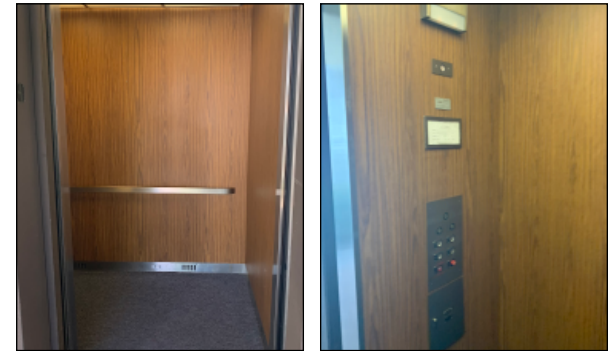
Office Elevator

- Path of travel compliance needs to be evaluated.
- The existing elevator is dated and needs to be updated to comply with current code. Note the finishes at the elevator also are dated and could use an update (re: smell concerns).
- The exterior stairwells were replaced ~20 years ago. The precast concrete treads are dated, and cracked. Consider replacing these stairwells in future work.
- Restrooms have had ADA upgrades.
- Drinking water is provided via a filtered system

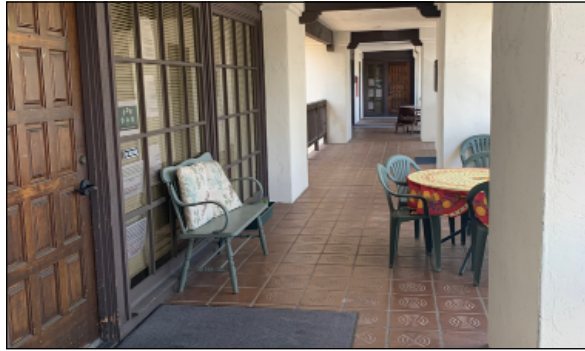
Office Exterior Verandas

- There are outdoor seating 'verandas' that are utilized for lunch and small group meetings. No improvements are suggested at this time.
- Note there is no photovoltaic system at this site. Consider researching future opportunities as local and state incentives come online.

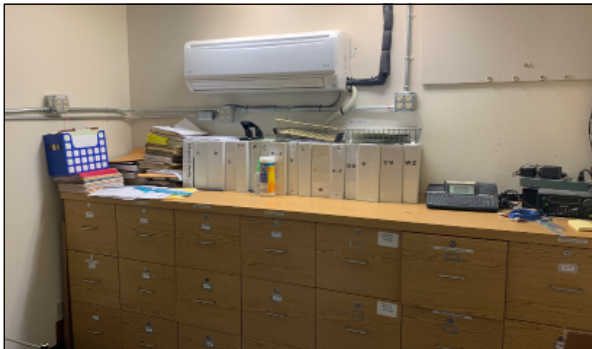
Office Interior - Administrative Services File Room

- In general, the interior finishes (flooring, painting) are in good condition. Flooring was recently replaced throughout the office building, but there is no consistent design that was utilized. Consider providing a consistent flooring update throughout office building in future work.
- Casework is in acceptable condition but could use an update.
- Ceilings are mostly ACT - tiles appear to be dated and in fair condition, recommend replacing these if rooms are updated in future work.
- Note there are existing lead walls at the interior Level 1 Administrative Services File Room.

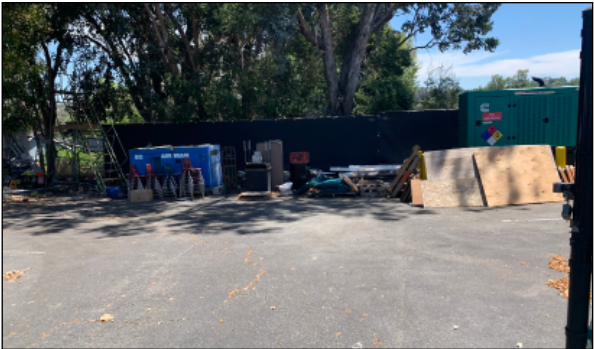
Site Power Generators/Storage Area

- There is an existing backup generator that it is utilized for the IT services, but has the capacity to provide power to the entire

site if needed. Wiring would need to be updated to provide this capability.

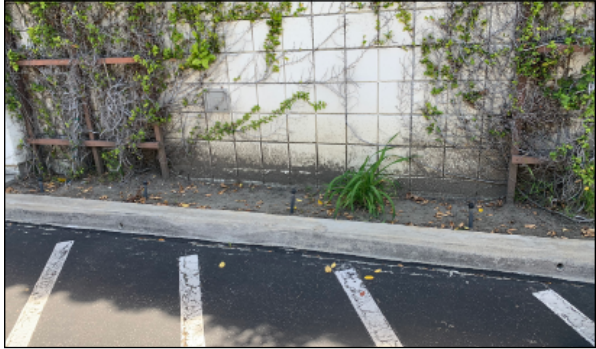
- During rain events, there are leaks in the warehouse that cause puddles in the interior. Consider adding drains to mitigate.

Warehouse Exterior - CMU Water Infiltration

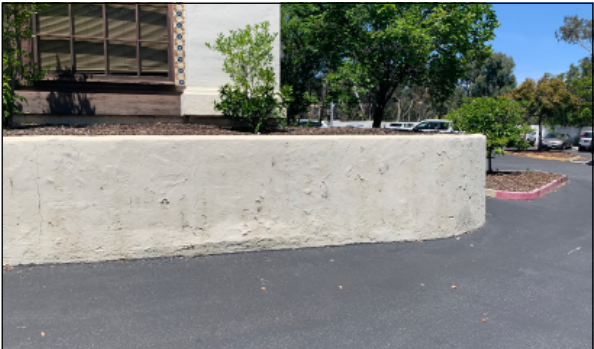
- Office buildings are wood construction with stucco exterior finish and are in general fair condition. Recommend repairing stucco in future work.
- Warehouse building is CMU construction - reference Drainage category for water infiltration issue.
- There is North parking area retaining wall/fence line that has been damaged and is in need of repair.

Site Wall - Stucco Condition

- Stucco areas could use a new coat of paint. Updated color scheme to reflect District colors.
