# EXISTING SITE CONDITIONS

## PAUL ECKE CENTRAL ELEMENTARY

Encinitas Union School District  
Facilities Plan Update

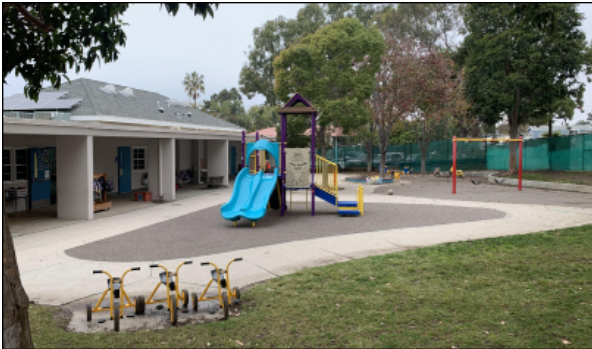
Kindergarten Play Area

- Concrete paving is in good condition at Kindergarten play and campus quad.
- Existing pavers appear to be in good condition.

- The natural turf (grass) at the area just south of the administration building would ideally be changed to artificial turf.
- The natural turf within the Kindergarten play area is slope and difficult for students to utilize - consider adjusting to accessible planted areas in future work.
- Desire for landscape areas to be upgraded to drought tolerant plants.
- More shade trees are recommended throughout campus.

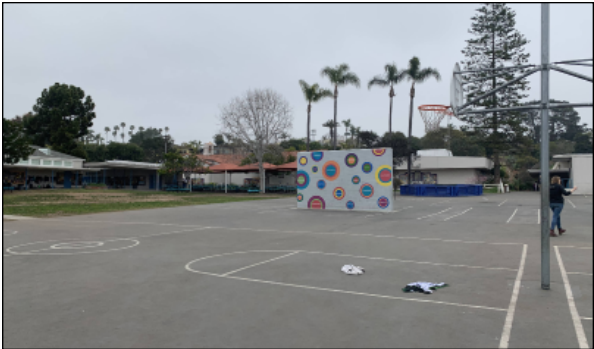
- Hardcourts are in fair condition with some areas cracking. Grind, re-seal and re-stripe.
- Verify potential cross slope issues (>2%).
- Worn striping in some areas.

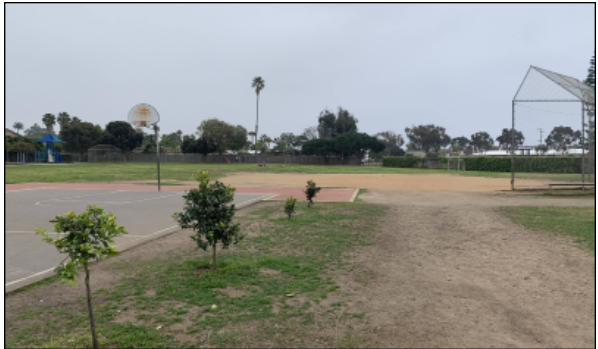
Playfields

- The main field at the south edge of the site has grading issues and existing potholes - requires constant maintenance due to

the overuse and traffic from the Leucadia Farmers Market.

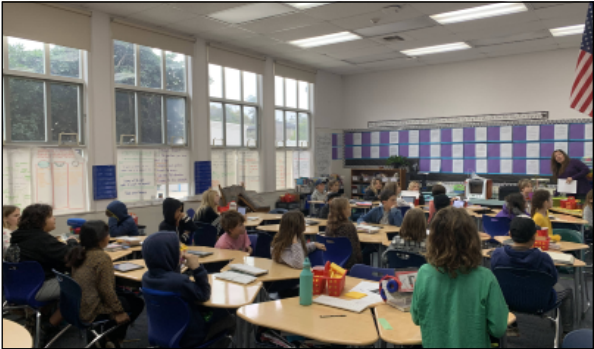
Typical Classroom

- In general, the interior finishes (flooring, painting and whiteboards) are in good condition and were last updated in the 2014-2015 school year. Casework is in acceptable condition but could use an update.

- Classroom ceilings are ACT-type; tiles are dated or damaged and should be replaced when future work is completed in these areas.
- The MPR has painted, glue down acoustic tile that is in good condition and appears to have been recently updated

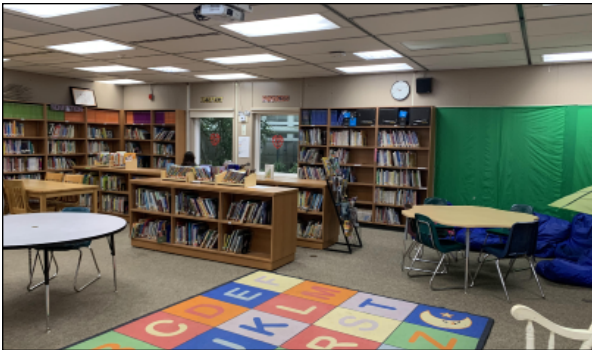
- Per information provided by the District's consultant, it is recommended to re-roof the Media Center building (existing coated emulsion system). A new coating is recommended at Portables 26, 27, 28, and 29 (existing metal roof).

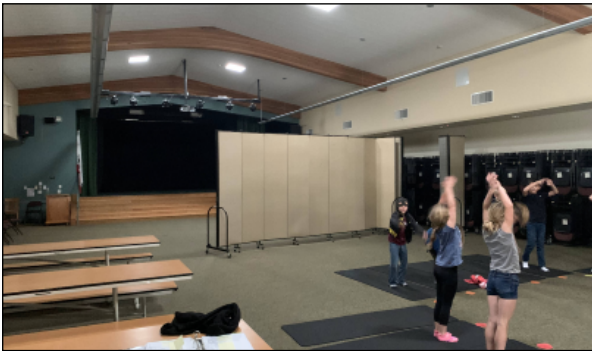
Multi-Purpose Room (MPR)

- MPR AV controls have been updated to be more-user friendly/current technology.
- LCD projectors are provided in all classrooms. Preference is for short-throw projectors in future work.

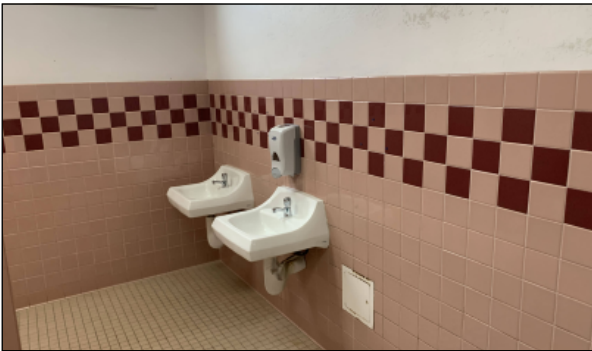
Typical Student Restroom

- Typical student and staff restrooms appear to have had ADA upgrades and meet accessible codes of that time. Due to code changes they will most likely need some upgrades if future work is to be done at existing buildings.
