# SAN MIGUEL / JUNTOS ELEMENTARY SCHOOL

SUNNYVALE SCHOOL DISTRICT | FACILITIES MASTER PLAN 2022

# FACILITY CONDITION ASSESSMENT

San Miguel / Juntos Elementary School  
777 San Miguel Avenue  
Sunnyvale, California 94087

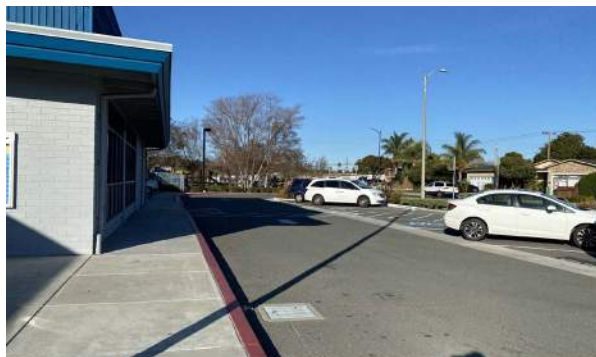
Drop-Off Lane / Parking

Parking and drop-off is extremely limited.

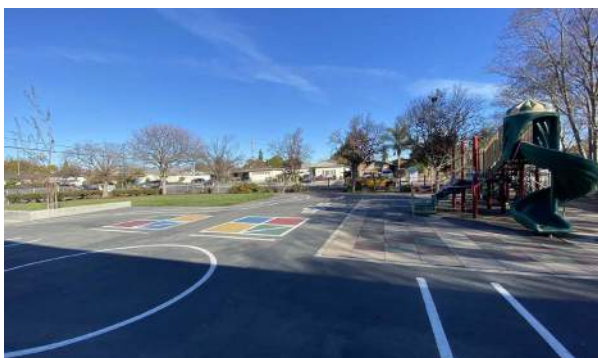
Kindergarten Play Yard

There are two (2) play areas for TK/Kindergarten, one at the front corner of campus and the other between the classroom buildings. This one is all asphalt paving with no landscaped area.

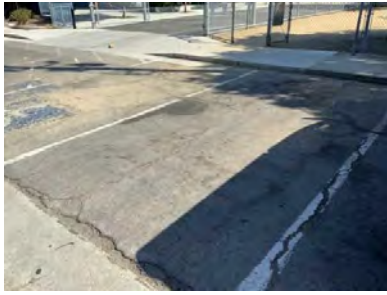
### Parking Lots in Poor condition.

Pavement, Asphalt  
Site San Miguel / Juntos Elementary School  
Site

Areas of asphalt parking are deteriorated and creating unsafe/uneven surfaces - AssetCALC ID: 2046372

Uniformat Code: G2021  
Recommendation: **Cut & Patch in 2021**

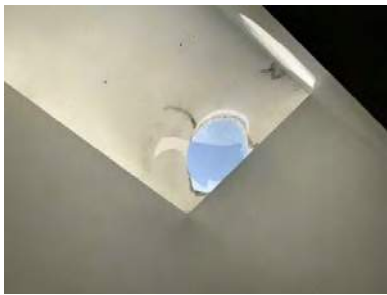
### Roof Skylight in Failed condition.

Per Unit, Up to 20 SF  
Classrooms C1-C4 San Miguel / Juntos  
Elementary School Roof

Both the inner and outer layer broken leaving the restroom below exposed to the atmosphere - AssetCALC ID: 2046588

Uniformat Code: B3061  
Recommendation: **Replace in 2021**

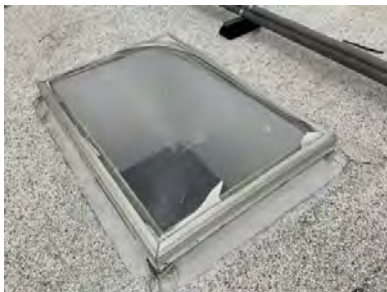
### Roof Skylight in Poor condition.

Per Unit, Up to 20 SF  
Classrooms D1-D4 San Miguel / Juntos  
Elementary School Roof

Outer skylight layer is all but completely broken and chipped away - AssetCALC ID: 2046330

Uniformat Code: B3061  
Recommendation: **Replace in 2021**
