# SITE FUNCTIONALITY ASSESSMENT **COLUMBIA MIDDLE SCHOOL**

SUNNYVALE SCHOOL DISTRICT | FACILITIES MASTER PLAN **2022**

# FACILITY CONDITION ASSESSMENT

Columbia Middle School  
739 Morse Avenue  
Sunnyvale, California 94085

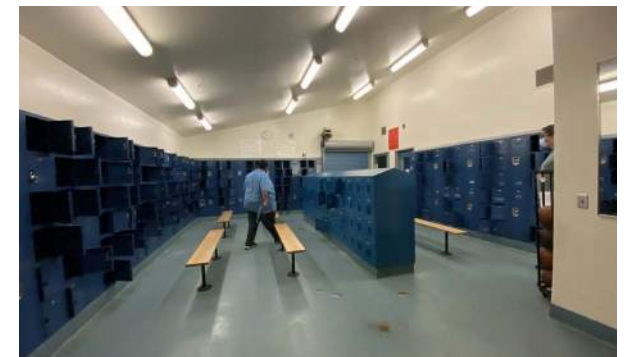
Locker Rooms (Boys)

The Girls Locker Rooms were newly constructed with the Multi-Purpose Room. The Boys Locker Room is attached to the Gym and are in poor condition.

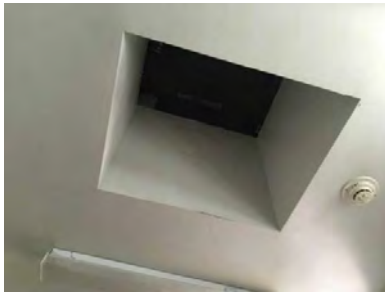
### Roof Appurtenances

Roof Access Ladder, Steel  
Cafeteria Columbia Middle School Roof

Missing ladder access. - AssetCALC ID: 2013524

Uniformat Code: B3021  
Recommendation: **Install in 2021**

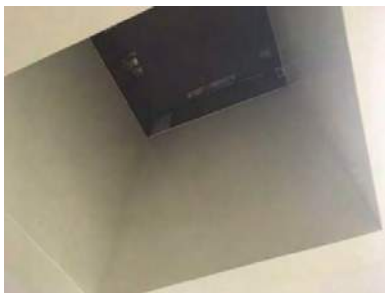
### Roof Appurtenances in Failed condition.

Roof Access Ladder, Steel  
Office/Library Columbia Middle School Roof

Missing ladder access to roof. - AssetCALC ID: 2013619

Uniformat Code: B3021  
Recommendation: **Install in 2021**

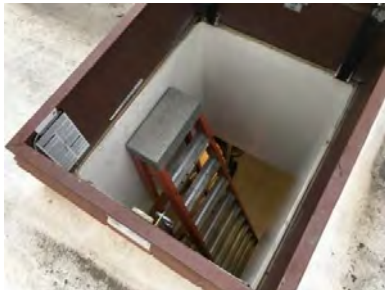
### Roof Appurtenances in Failed condition.

| <u>ID</u> | <u>Location</u> | <u>Location Description</u> | <u>UF Code</u> | <u>Description</u> | <u>Condition</u> | <u>Plan Type</u> | <u>Cost</u> |
|---|---|---|---|---|---|---|---|
| 2013511 | Columbia Middle School / CMS | Roof | B3020 | Roof Appurtenances, Roof Access Ladder, Steel, Install | Failed | Safety | \$1,800 |

Roof Access Ladder, Steel  
CMS Columbia Middle School Roof

Fixed roof ladder missing - AssetCALC ID: 2013511

Uniformat Code: B3021  
Recommendation: **Install in 2021**

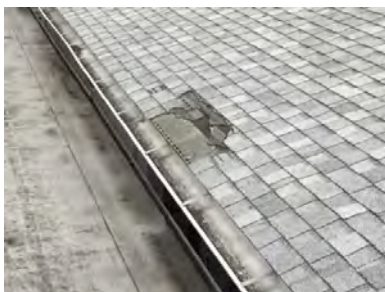
### Roofing in Poor condition.

| <u>ID</u> | <u>Location</u> | <u>Location Description</u> | <u>UF Code</u> | <u>Description</u> | <u>Condition</u> | <u>Plan Type</u> | <u>Cost</u> |
|---|---|---|---|---|---|---|---|
| 2013627 | Columbia Middle School / Office/Library | Roof | B3010 | Roofing, any type, Repairs Asphalt shingle, Repair | Poor | Performance/Integrity | \$1,100 |

any type, Repairs Asphalt shingle  
Office/Library Columbia Middle School Roof

Roof shingle needs replacement. - AssetCALC ID: 2013627

Uniformat Code: B3015  
Recommendation: **Repair in 2021**

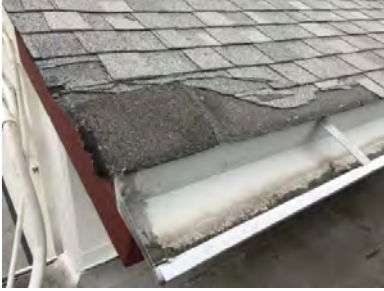
### Shingle Roofing in Poor condition.

| <u>ID</u> | <u>Location</u> | <u>Location Description</u> | <u>UF Code</u> | <u>Description</u> | <u>Condition</u> | <u>Plan Type</u> | <u>Cost</u> |
|---|---|---|---|---|---|---|---|
| 2013550 | Columbia Middle School / Classroom 40 | Roof | B3010 | Shingle Roofing, Shingle repair, Repair | Poor | Performance/Integrity | \$1,100 |

Shingle repair  
Classroom 40 Columbia Middle School Roof

Replace the shingle on the edge of the roof. - AssetCALC ID: 2013550

Uniformat Code: B3015  
Recommendation: **Repair in 2021**

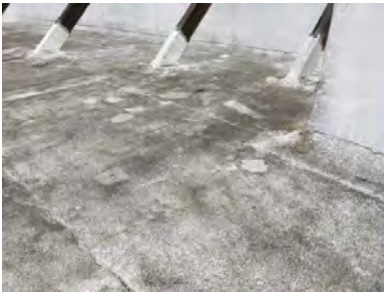
### Roofing in Poor condition.

| <u>ID</u> | <u>Location</u> | <u>Location Description</u> | <u>UF Code</u> | <u>Description</u> | <u>Condition</u> | <u>Plan Type</u> | <u>Cost</u> |
|---|---|---|---|---|---|---|---|
| 2013603 | Columbia Middle School / Office/Library | Roof | B3010 | Roofing, Modified Bitumen, Replace | Poor | Performance/Integrity | \$61,000 |

Modified Bitumen  
Office/Library Columbia Middle School Roof

There are lots of potholes and bubbles on the roofs. - AssetCALC ID: 2013603

Uniformat Code: B3015  
Recommendation: **Replace in 2021**

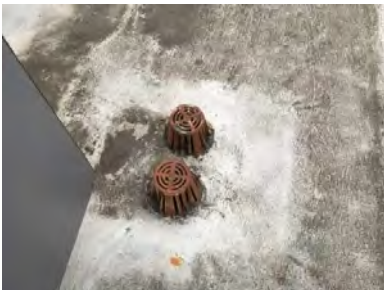
### Roofing in Poor condition.

| <u>ID</u> | <u>Location</u> | <u>Location Description</u> | <u>UF Code</u> | <u>Description</u> | <u>Condition</u> | <u>Plan Type</u> | <u>Cost</u> |
|---|---|---|---|---|---|---|---|
| 2013503 | Columbia Middle School / CMS | Roof | B3010 | Roofing, Modified Bitumen, Replace | Poor | Performance/Integrity | \$37,500 |

Modified Bitumen  
CMS Columbia Middle School Roof

Blister and bubbles observed on the roof. - AssetCALC ID: 2013503

Uniformat Code: B3015  
Recommendation: **Replace in 2021**

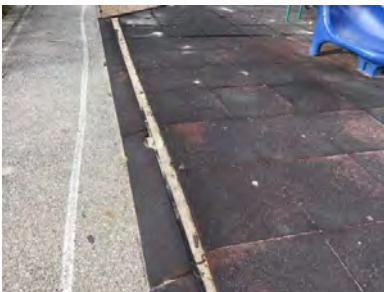
### Playfield Surfaces in Poor condition.

| ID | Location | Location Description | UF Code | Description | Condition | Plan Type | Cost |
|---|---|---|---|---|---|---|---|
| 2013813 | Columbia Middle School / Site | Site- Adjacent to PS3-PS5 | G2050 | Playfield Surfaces, Rubber, 6" Depth, Replace | Poor | Performance/Integrity | \$10,500 |

Rubber, 6" Depth  
Site Columbia Middle School Site- Adjacent to PS3-PS5

The rubber has warped and cracked. - AssetCALC ID: 2013813

Uniformat Code: G2055  
Recommendation: **Replace in 2021**
