**DISTRICTWIDE FACILITIES ASSESSMENT 2022**  
WOODLAND JOINT UNIFIED SCHOOL DISTRICT

SITE PACKAGE  
**PLAINFIELD ELEMENTARY**

# FACILITY CONDITION ASSESSMENT

Plainfield Elementary  
20450 County Road 97,  
Woodland, California 95695

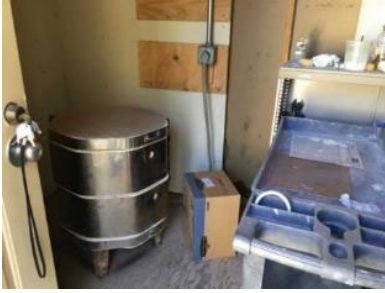
### Vent kiln

Ductwork and fan  
Building A1-A3 Plainfield Elementary Kiln room

Uniformat Code: D3055  
Recommendation: **Install in 2021**

Add ductwork and venting for the kiln room. - AssetCALC ID: 2960088

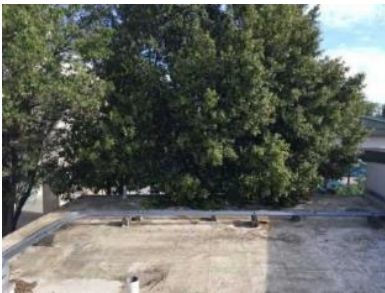
### Landscaping in Poor condition.

Mature Trees, Removal or Heavy Trimming  
Building D Plainfield Elementary Building D

Uniformat Code: G2083  
Recommendation: **Repair in 2021**

Trim tree branches such that it does not block roof drainage. - AssetCALC ID: 2960102

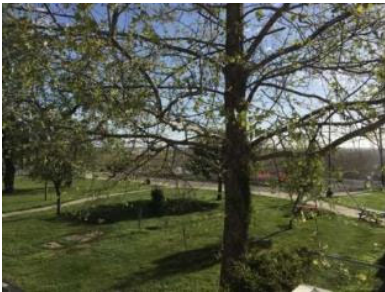
### Landscaping in Poor condition.

Mature Trees, Heavy Trimming  
Site Plainfield Elementary Site

Uniformat Code: G2083  
Recommendation: **Repair in 2021**

According to POC, the wind causes the branches to fall. Some of the trees need to have their branches trimmed. - AssetCALC ID: 2960112

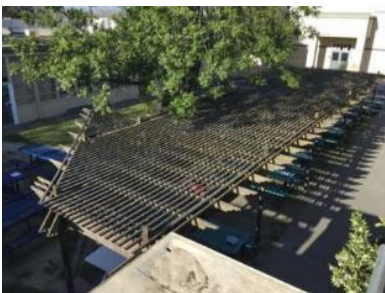
### Shade Roofing in Poor condition.

Wood Strip  
Site Plainfield Elementary Roof

Uniformat Code: B3011  
Recommendation: **Clean in 2022**

on the wooden - AssetCALC ID: 2960093

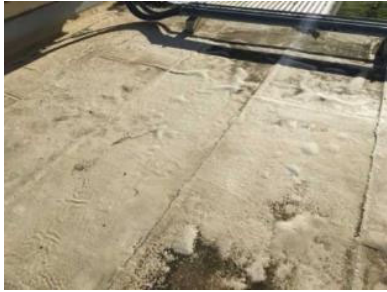
### Roofing in Poor condition.

Single-Ply Membrane, TPO/PVC  
Building D Plainfield Elementary Roof

Uniformat Code: B3015  
Recommendation: **Replace in 2022**

The roof shows signs of multiple blisters throughout and will need replacement soon. - AssetCALC ID: 2960072

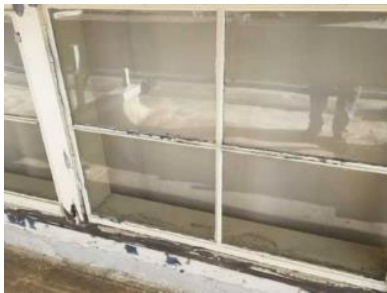
### Window in Poor condition.

Steel, up to 15 SF  
Building D Plainfield Elementary Building  
exterior

Uniformat Code: B2021  
Recommendation: **Replace in 2022**

Exterior leaky windows which will need replacement in the near future. - AssetCALC ID: 2960139

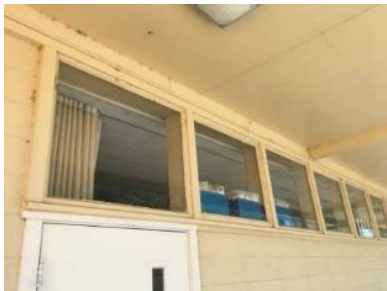
### Window in Poor condition.

Steel, up to 15 SF  
Building B1-B3 Plainfield Elementary Exterior  
wall

Uniformat Code: B2021  
Recommendation: **Replace in 2023**

Older single pane windows need to be upgraded to double pane. - AssetCALC ID: 2990581

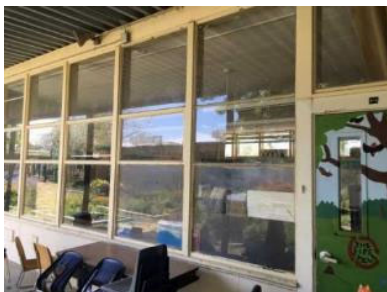
### Window in Poor condition.

Steel, 28-40 SF  
Building A1-A3 Plainfield Elementary Exterior  
wall

Uniformat Code: B2021  
Recommendation: **Replace in 2023**

Older single pane windows need to be upgraded to double pane. - AssetCALC ID: 2990636

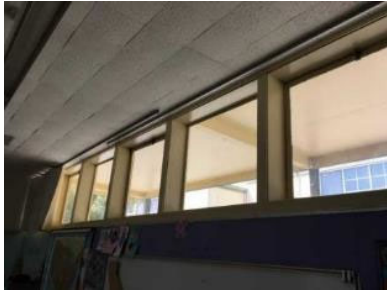
### Window in Poor condition.

Steel, up to 15 SF  
Building A1-A3 Plainfield Elementary Exterior wall

Uniformat Code: B2021  
Recommendation: **Replace in 2023**

Older single pane windows need to be upgraded to double pane. - AssetCALC ID: 2990562

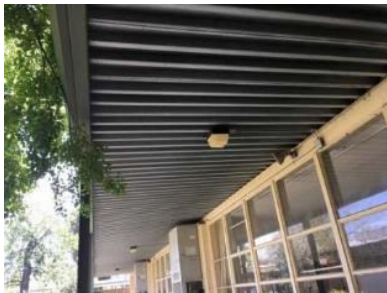
### Window in Poor condition.

Steel, 28-40 SF  
Building B1-B3 Plainfield Elementary Exterior wall

Uniformat Code: B2021  
Recommendation: **Replace in 2023**

Older single pane windows need to be upgraded to double pane. - AssetCALC ID: 2990854

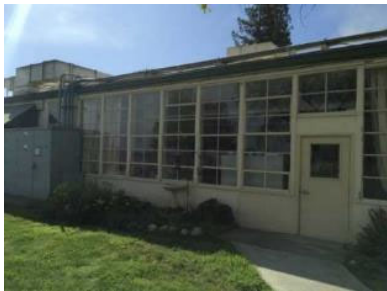
### Window single pane in Poor condition.

Steel, 28-40 SF  
Building D Plainfield Elementary Building exterior

Uniformat Code: B2021  
Recommendation: **Replace in 2023**

Older single pane windows need to be upgraded to double pane. - AssetCALC ID: 2960059

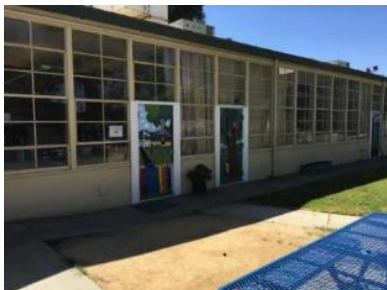
### Window in Poor condition.

Steel, 28-40 SF  
Building D Plainfield Elementary Exterior wall

Uniformat Code: B2021  
Recommendation: **Replace in 2023**
