**DISTRICTWIDE FACILITIES ASSESSMENT 2022**  
WOODLAND JOINT UNIFIED SCHOOL DISTRICT

SITE PACKAGE  
**LEE MIDDLE**

# FACILITY CONDITION ASSESSMENT

Lee Middle School  
520 West Street  
Woodland, California 95695

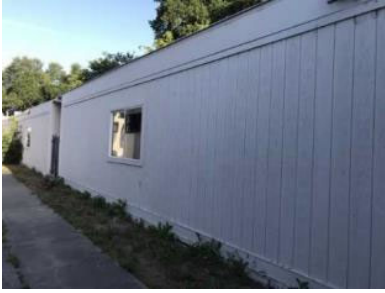
### Exterior Walls in Poor condition.

Textured Plywood (T1-11)  
Portables-36-38 Lee Middle School Building  
Exterior

Water has corroded the siding nails. Exposed holes have allowed water in. Siding is starting to dry rot and delaminated, pulling away from structure. - AssetCALC ID: 2983871

Uniformat Code: B2011  
Recommendation: **Replace in 2022**

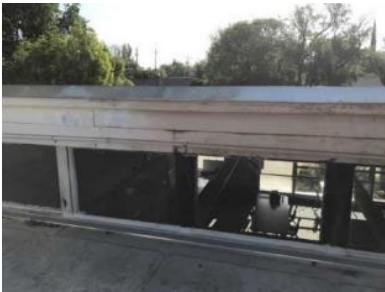
### Exterior Walls in Poor condition.

Wood Clapboard Siding, 1-2 Story Building  
Building-5 Lee Middle School Building exterior

Boards are warping and pulling away from building - AssetCALC ID: 2983124

Uniformat Code: B2011  
Recommendation: **Replace in 2022**

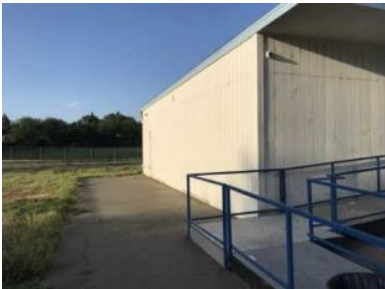
### Exterior Walls in Poor condition.

Textured Plywood (T1-11)  
Portables-46-48 Lee Middle School Building  
Exterior

Siding is damaged and pulling away around the portables - AssetCALC ID: 2983902

Uniformat Code: B2011  
Recommendation: **Replace in 2022**

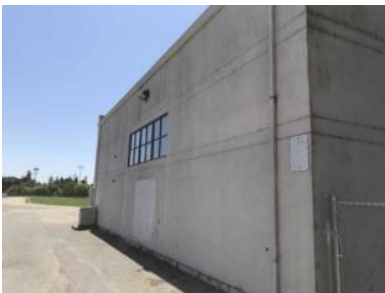
### Exterior Walls in Poor condition.

Stucco, 1-2 Story Building  
Building-10 Lee Middle School Building exterior

Large chunks are missing - AssetCALC ID: 2983830

Uniformat Code: B2011  
Recommendation: **Replace in 2023**

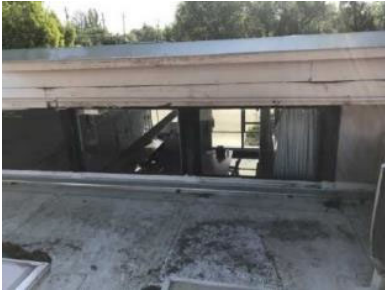
| ID | Location | Location Description | UF Code | Description | Condition | Plan Type | Cost |
|---|---|---|---|---|---|---|---|
| 2983127 | Lee Middle School / Building-5 | Building exterior | B2020 | Window, Steel, up to 15 SF, Replace | Poor | Performance/Integrity | \$8,900 |

### Window in Poor condition.

Steel, up to 15 SF  
Building-5 Lee Middle School Building exterior

Seals are rotting away or are completely gone - AssetCALC ID: 2983127

Uniformat Code: B2021  
Recommendation: **Replace in 2021**

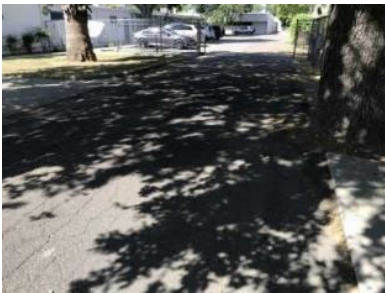
### Parking Lots in Poor condition.

Pavement, Asphalt  
Site Lee Middle School Site

Potholes, longitudinal cracking, alligator cracking throughout - AssetCALC ID: 2982870

Uniformat Code: G2021  
Recommendation: **Mill & Overlay in 2022**

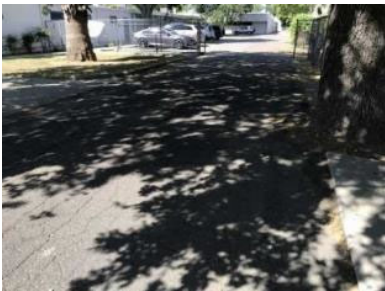
### Parking Lots in Poor condition.

Pavement, Asphalt  
Site Lee Middle School Site

Potholes, longitudinal cracking, alligator cracking throughout - AssetCALC ID: 2982869

Uniformat Code: G2021  
Recommendation: **Seal & Stripe in 2022**

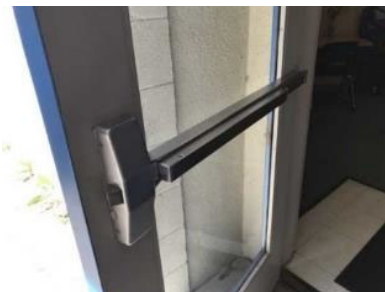
### Door Hardware in Poor condition.

School, per Door  
Building-6 Lee Middle School Building exterior

Door is difficult to open and the hardware needs to be replaced. - AssetCALC ID: 2986418

Uniformat Code: C1039  
Recommendation: **Replace in 2023**

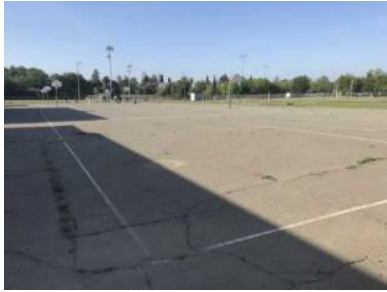
### Athletic Surfaces & Courts in Poor condition.

Basketball/General, Asphalt Pavement  
Site Lee Middle School Basketball Court

Longitudinal cracking throughout - AssetCALC ID: 2990477

Unifomat Code: G2051  
Recommendation: **Replace in 2023**

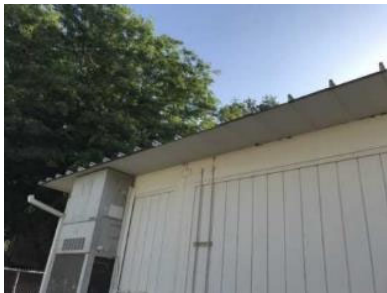
| ID | Location | Location Description | UF Code | Description | Condition | Plan Type | Cost |
|---|---|---|---|---|---|---|---|
| 2983869 | Lee Middle School / Portables-36-38 | Roof | B3020 | Roof Appurtenances, Gutters & Downspouts, Aluminum w/ Fittings, Replace | Failed | Performance/Integrity | \$300 |

### Roof Appurtenances in Failed condition.

Gutters & Downspouts, Aluminum w/ Fittings  
Portables-36-38 Lee Middle School Roof

Gutter is missing from 36 roof edge - AssetCALC ID: 2983869

Unifomat Code: B3027  
Recommendation: **Replace in 2021**

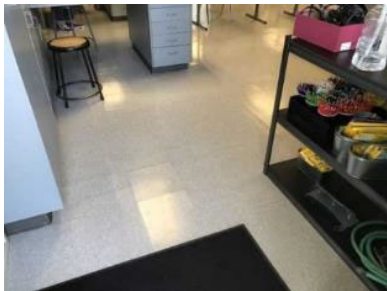
| ID | Location | Location Description | UF Code | Description | Condition | Plan Type | Cost |
|---|---|---|---|---|---|---|---|
| 2983894 | Lee Middle School / Portables-46-48 | Throughout building | C2030 | Flooring, Vinyl Tile (VCT), Replace | Poor | Performance/Integrity | \$13,400 |

### Flooring in Poor condition.

Vinyl Tile (VCT)  
Portables-46-48 Lee Middle School Throughout building

Tiles are cracked, dirty, and pulling off the floor - AssetCALC ID: 2983894

Unifomat Code: C2035  
Recommendation: **Replace in 2021**

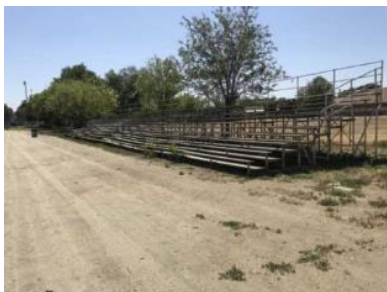
| ID | Location | Location Description | UF Code | Description | Condition | Plan Type | Cost |
|---|---|---|---|---|---|---|---|
| 2982859 | Lee Middle School / Site | Site | E2010 | Bleachers, Fixed Steel Frame, Aluminum Benches (per Seat), Replace | Poor | Performance/Integrity | \$132,700 |

### Bleachers in Poor condition.

Fixed Steel Frame, Aluminum Benches (per Seat)  
Site Lee Middle School Site

Unifomat Code: E2017  
Recommendation: **Replace in 2021**
