**DISTRICTWIDE FACILITIES ASSESSMENT 2022**  
WOODLAND JOINT UNIFIED SCHOOL DISTRICT

SITE PACKAGE  
**TAFOYA ELEMENTARY**

# FACILITY CONDITION ASSESSMENT

Tafoya Elementary  
720 Homestead Way  
Woodland, California 95776

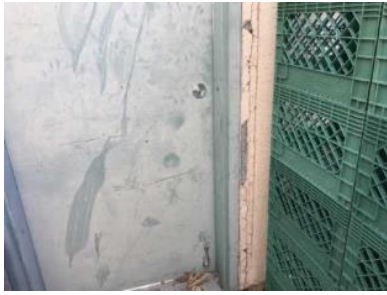
### Exterior Walls in Poor condition.

Stucco, 1-2 Story Building  
B-MPR Tafoya Elementary Gate jamb

The service yard gate jamb is damaged and requires stucco repair. BV recommends installing a post protector to prevent future damage from deliveries. - AssetCALC ID: 2978737

Uniformat Code: B2011  
Recommendation: **Repair in 2021**

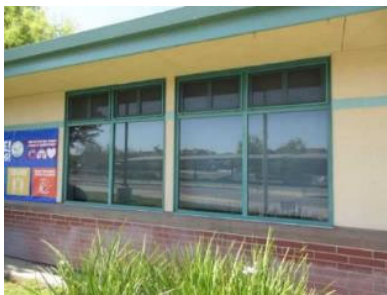
### Window in Poor condition.

Steel, any type  
A-Administration Tafoya Elementary Building exterior

Exterior paint finish is deteriorating. - AssetCALC ID: 2979265

Uniformat Code: B2021  
Recommendation: **Refinish in 2022**

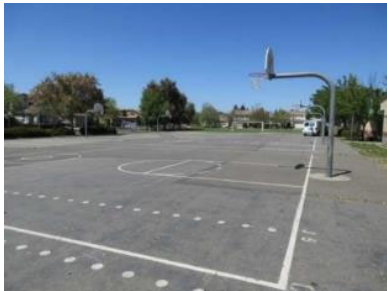
### Athletic Surfaces & Courts in Poor condition.

Basketball/General, Asphalt Pavement  
Site Tafoya Elementary Playground, west

The asphalt is separating significantly. - AssetCALC ID: 2978913

Uniformat Code: G2051  
Recommendation: **Mill & Overlay in 2022**

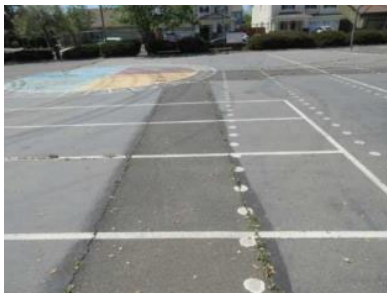
### Athletic Surfaces & Courts in Poor condition.

Basketball/General, Asphalt Pavement  
Site Tafoya Elementary Playground, west

The playground requires mill and overlay, with seal and stripe in the near future. - AssetCALC ID: 2980616

Uniformat Code: G2051  
Recommendation: **Seal & Stripe in 2022**

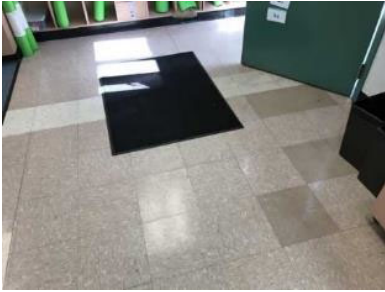
### Flooring in Poor condition.

Vinyl Tile (VCT)  
D-Kindergarten Tafoya Elementary Building  
interior-D3

The VCT is mismatched and cracking. - AssetCALC ID: 2980240

Uniformat Code: C2035  
Recommendation: **Replace in 2021**

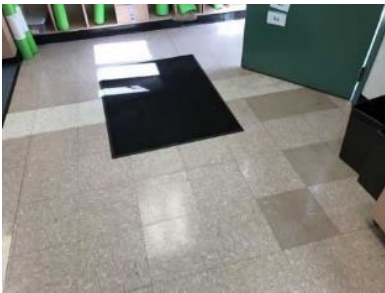
### Flooring in Poor condition.

Vinyl Tile (VCT)  
D-Kindergarten Tafoya Elementary Building  
interior-D3

The VCT is mismatched, with cracks and gaps. - AssetCALC ID: 2980232

Uniformat Code: C2035  
Recommendation: **Replace in 2021**

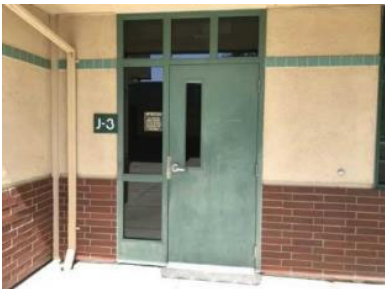
### Exterior Door in Poor condition.

Steel, any type  
J & K Modular Classrooms Tafoya Elementary  
Building exterior

The exterior finish is powdery and deteriorating. - AssetCALC ID: 2979334

Uniformat Code: B2051  
Recommendation: **Refinish in 2022**

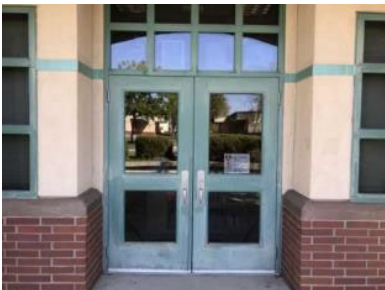
### Exterior Door in Poor condition.

Steel, any type  
C-Media Tafoya Elementary Building exterior

The exterior finish is powdery and deteriorating. - AssetCALC ID: 2979329

Uniformat Code: B2051  
Recommendation: **Refinish in 2022**

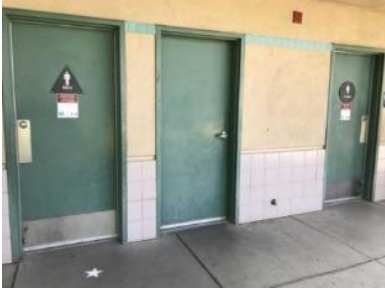
**Exterior Door in Poor condition.**

Steel, any type  
Toilet Buildings Tafoya Elementary Building  
exterior

The exterior finish is powdery and deteriorating. - AssetCALC ID: 2979336

Uniformat Code: B2051  
Recommendation: **Refinish in 2022**

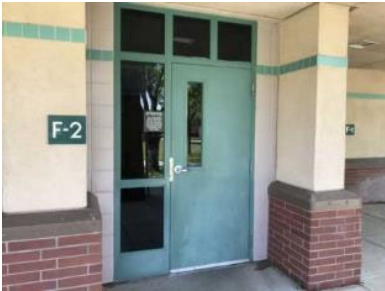
**Exterior Door in Poor condition.**

Steel, any type  
E & F Classrooms Tafoya Elementary Building  
exterior

The exterior finish is powdery and deteriorating. - AssetCALC ID: 2979333

Uniformat Code: B2051  
Recommendation: **Refinish in 2022**

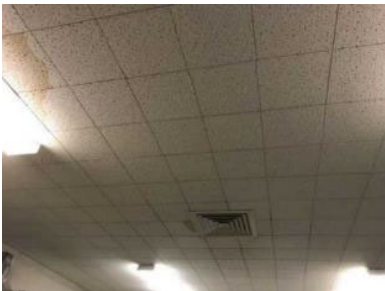
**Ceilings in Poor condition.**

Hard Tile, Replacement w/ ACT  
B-MPR Tafoya Elementary Classroom

Ceiling tiles are stained and dislodged. - AssetCALC ID: 2978776

Uniformat Code: C1071  
Recommendation: **Replace in 2022**
