# EXISTING SITE CONDITIONS

## LA COSTA HEIGHTS ELEMENTARY

Encinitas Union School District  
Facilities Plan Update

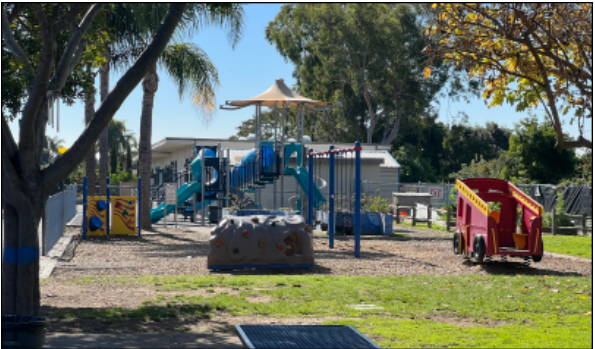
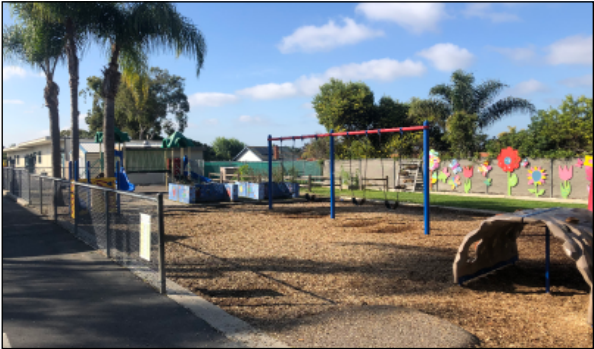
Kindergarten Play Area

- Recommend adding storm drain inlets at the Kindergarten play area to address current drainage issues.

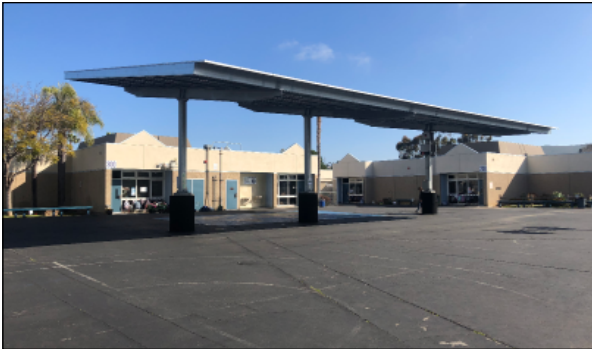
- Hardcourts were last replaced and added to the site in Fall 2018.
- Verify potential cross slope issues (>2%).
- Worn striping in some areas.

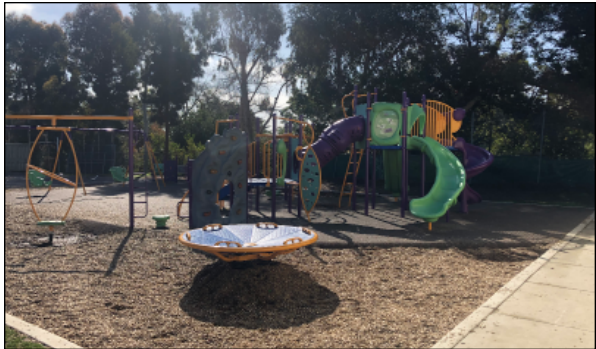
Play Apparatus

- Kindergarten play equipment was updated in Summer 2020, and existing sand box was removed.
- Play equipment for lower grades was last replaced 2006 and is in fair condition.
- Play equipment for upper grades was last replaced in the 2017-2018 school year and is in good condition.
- Replace fiber chips in fall zone with rubberized surfacing.
- Ball wall is in good condition.
- Swings are in good condition, replace fiber chips with rubber.
- Basketball goals and posts are in good condition.
- Baseball infield areas should be removed or re-worked. Potential replacement of backstops.

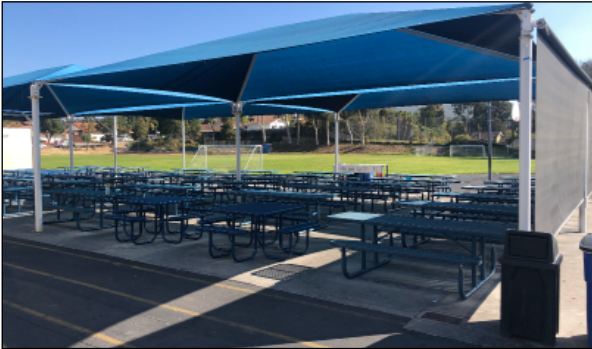
Lunch Shelter

- Repaint shelter and fence.
- Track is DG/grass - Replace with rubberized surfacing.
- Dedicated outdoor learning spaces were requested.

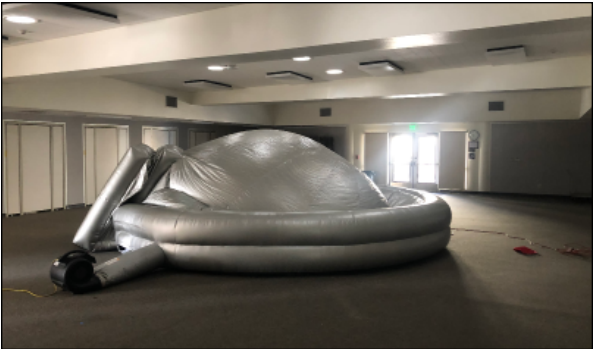
Multi-Purpose Room (MPR)

- Flooring was updated in the 2017-2018 school year, but has carpet ripped seams and areas that need to be replaced. Recommend replacing carpet in future work. MPR also currently has carpet- recommend replacing this with resilient flooring to better support space function.
- Casework is in acceptable condition but could use an update.
- Classroom ceilings are ACT-type; tiles are dated or damaged and should be replaced when future work is completed in these areas.

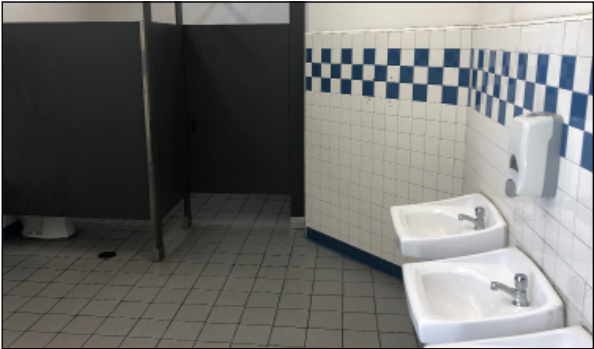
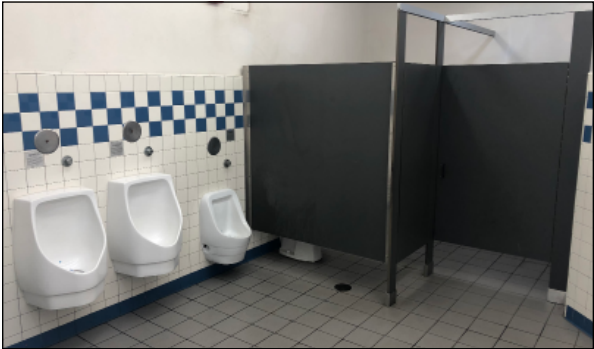
Typical Student Restroom

- Plumbing piping within buildings is understood to be original to the 1987 construction and should be replaced.
- Typical student and staff restrooms appear to have had ADA upgrades and meet accessible codes of that time. Due to code changes they will most likely need some upgrades if future work is to be done at existing buildings.
