# EXISTING SITE CONDITIONS

## EL CAMINO CREEK ELEMENTARY

Encinitas Union School District  
Facilities Plan Update

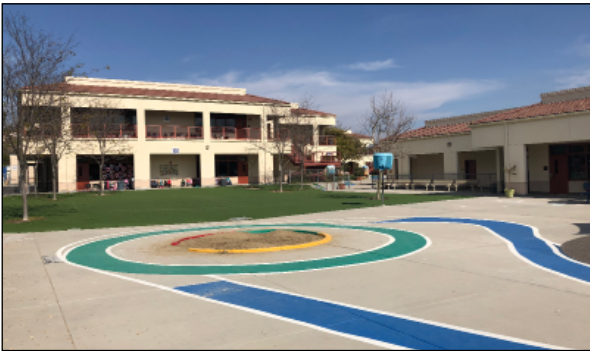
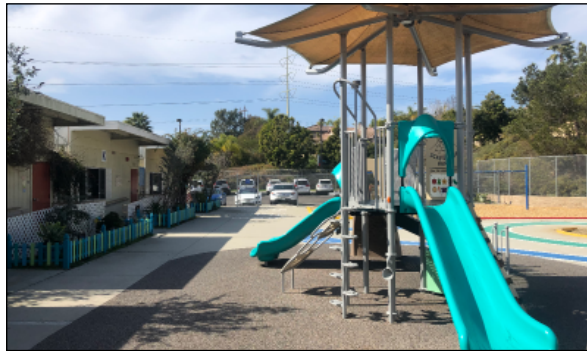
Kindergarten Play Area

- Garden has (3) distinct learning areas, which the site would like to maintain. The location at front of campus with visibility is good.
- Kinder grass play area is not very functional due to the trees in it. Ideal to remove trees and add shade so that children can play games and run without tree obstructions. Shade needed.

- Surface drainage ponding at the Northwest corner of the campus at Kinder play area near sandbox needs to be addressed.
- Storm drainage modifications were previously completed at the east edge of the site - repairs adequately addressed drainage issues at this area.

1. Shade over kinder play area, remove trees from kinder turf area.
2. Garden stay where it is with the (3) distinct learning areas
3. Campus wide storage needed.
4. Upgrades to lunch area: More permanent / weatherproof structure, reconsider fencing around lunch area.
5. Landscape improvements and shade enhancements throughout

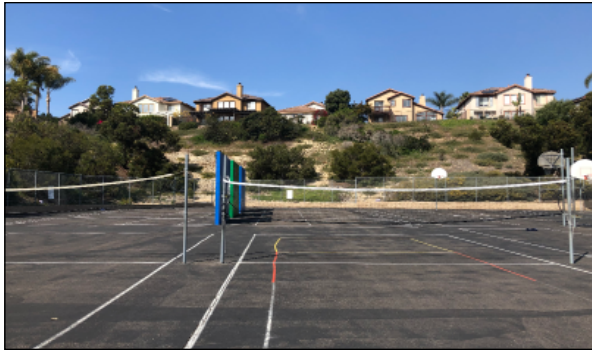
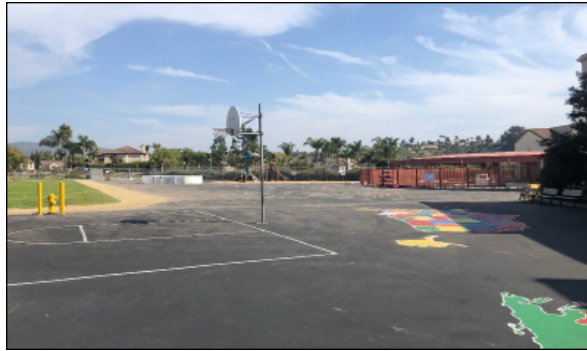
- Hardcourts are in fair condition with some areas cracking. Grind, re-seal and re-stripe.
- Verify potential cross slope issues (>2%).
- Worn striping in some areas.

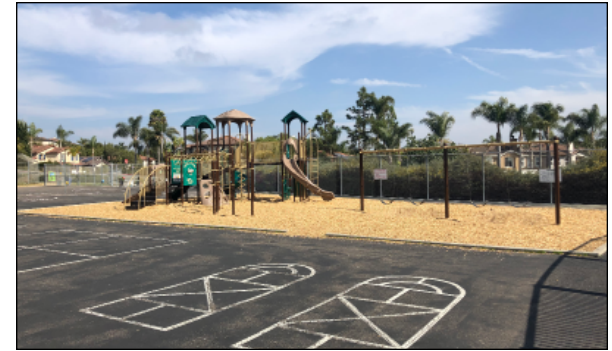
Play Apparatus

- The main play equipment north of shade structure was installed in the 2017/2018 school year and is in good condition.
- Replace fiber chips in fall zone with rubberized surfacing.
- Ball wall is in good condition.
- Swings are in good condition, replace fiber chips with rubber.
- Basketball goals and posts are in good condition.
- Baseball infield areas should be removed or re-worked. Potential replacement of backstops.
