# EXISTING SITE CONDITIONS

## OLIVENHAIN PIONEER ELEMENTARY

Encinitas Union School District  
Facilities Plan Update

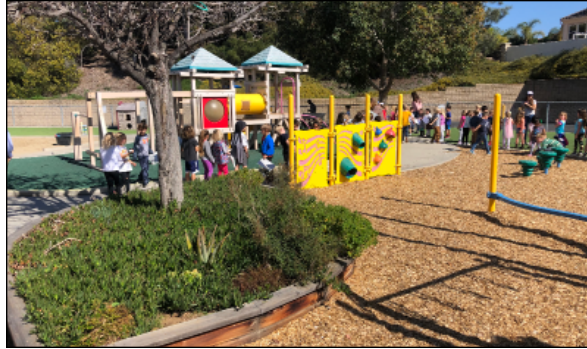
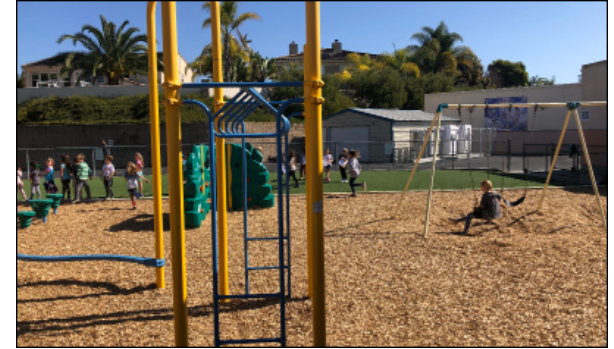
Kindergarten Play Area

- The Kindergarten play equipment was most replaced in the 2008-2009 school year and was added to in the 2011-2012 school year.
- The existing play equipment for other grades are dated and accessibility/safety issues were noted. Recommend replacing this play equipment in future work.
- Replace fiber chips in fall zone with rubberized surfacing.
- Ball wall is in good condition.
- Swings are in good condition, replace fiber chips with rubber.
- Basketball goals and posts are in good condition.

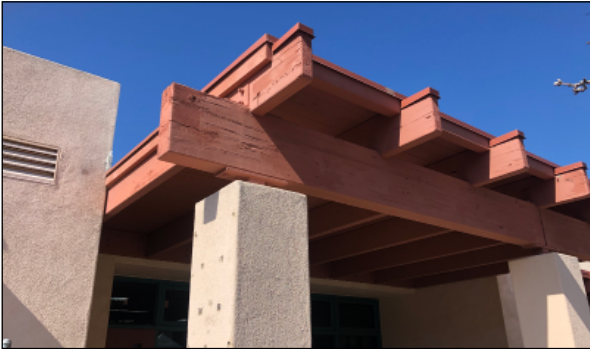
Aging Beams at Kindergarten Building

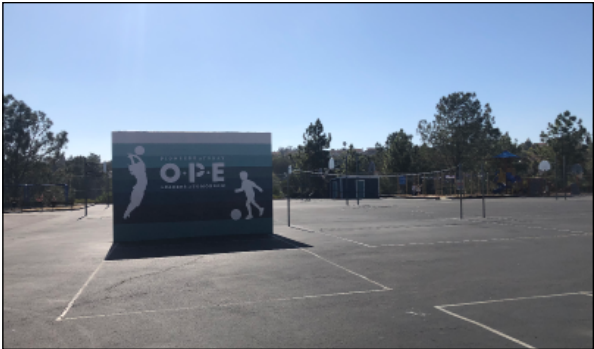
- Hardcourts are in good condition and were last replaced in Summer 2018. Striping was also updated.
- Verify potential cross slope issues (>2%).

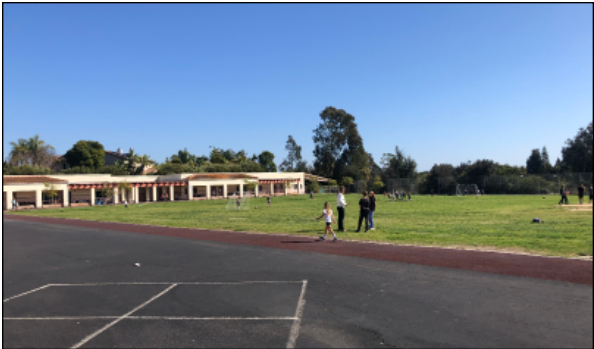
Playfields

- Track is DG/grass and is in poor condition. Recommendation is to replace with rubberized surfacing.
- Dedicated outdoor learning spaces were requested.

- Grass areas should be reseeded and regraded.
- Desire for landscape areas to be upgraded to drought tolerant plants.
- More shade trees are recommended throughout campus.

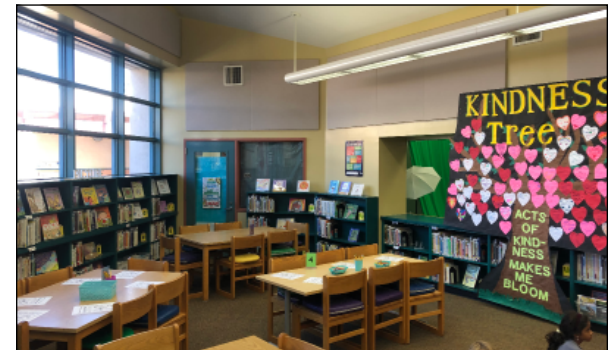
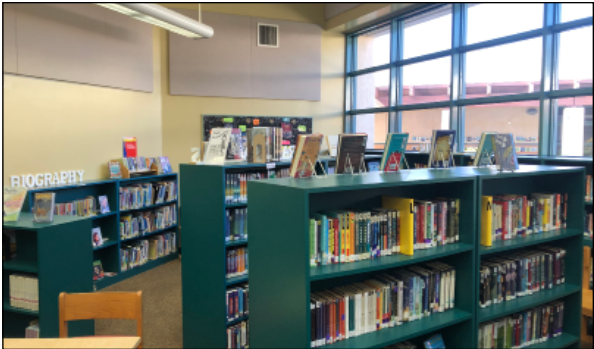
- Prioritize outdoor shade.
- Media Center is dated and should be centralized to engage more students.
- Consider replacing the dated A/V, lighting and sound systems.
- Lockable storage to free up pod spaces.
- Provide a shaded area outside at staff lounge
- Increase access to electrical receptacles for charging stations.
- Add water to the science labs
- Upgrades and better working HVAC controls

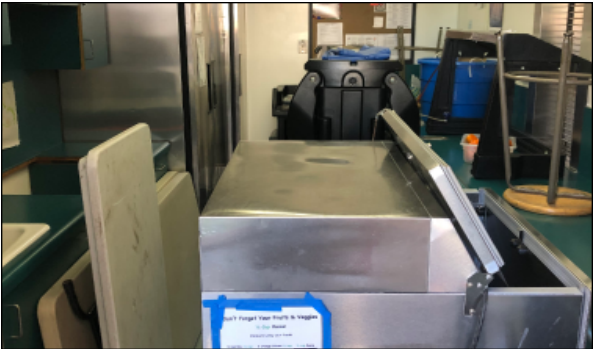
Kitchen

- desired
- Finish the track around the field
- Remove wood chips at play area, and address drainage issues
- Existing kitchen is small and needs to be improved. Existing kitchen could be changed to a storage closet with backstage access behind the MPR if kitchen was relocated.
