# EXISTING SITE CONDITIONS

## OCEAN KNOLL ELEMENTARY

Encinitas Union School District  
Facilities Plan Update

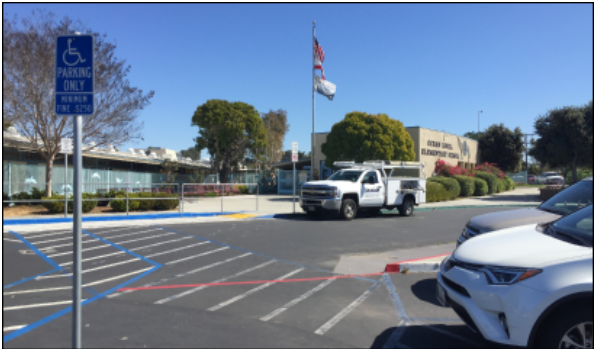
Drop-off Loop

- Back parking lot access to school raises some safety concerns. No clear drop off area/dead-end circulation.

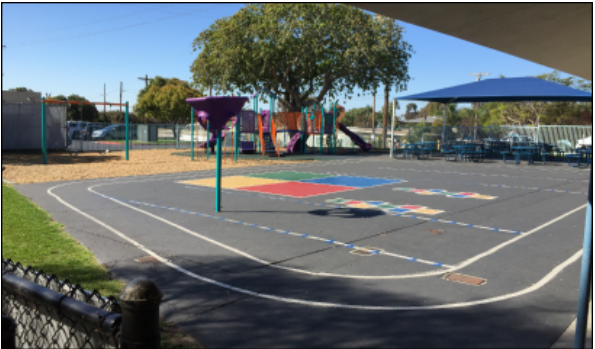
Kindergarten Play Area

- Concrete paving is in good condition at Kindergarten play and campus quad.

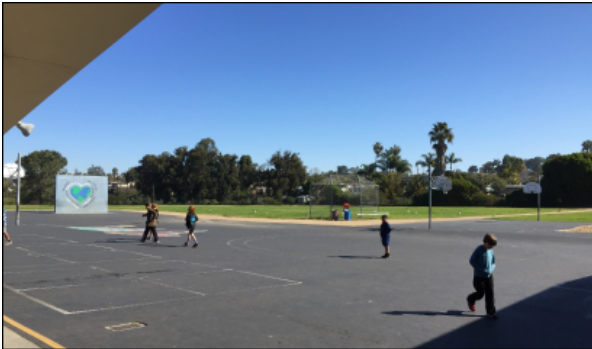
- Hardcourts are in fair condition with some areas cracking. Grind, re-seal and re-stripe.
- Verify potential cross slope issues (>2%).
- Worn striping has been recently repaired.

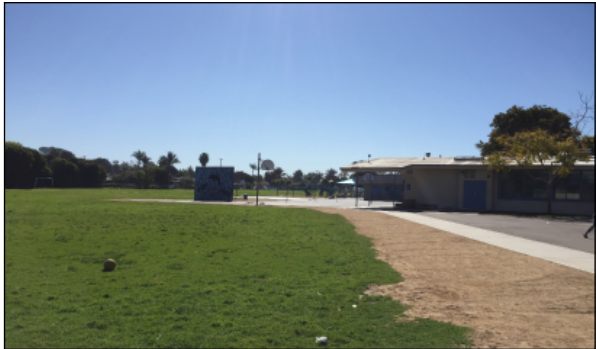
Playfields

- Grass areas should be reseeded and regraded.
- Desire for landscape areas to be upgraded to drought tolerant plants.
- More shade trees are recommended throughout campus.

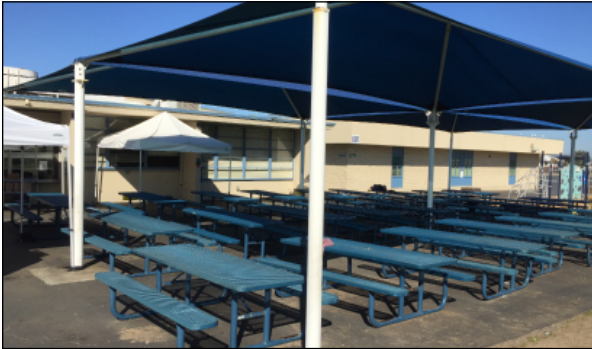
Lunch Shelter

- surfacing
- Weather proof lunch shelter for inclement weather
- Shade opportunity at northern classrooms - shade sails are inefficient for outdoor learning
- Rightsize remaining kinder classroom to CDE standard (1350sf)

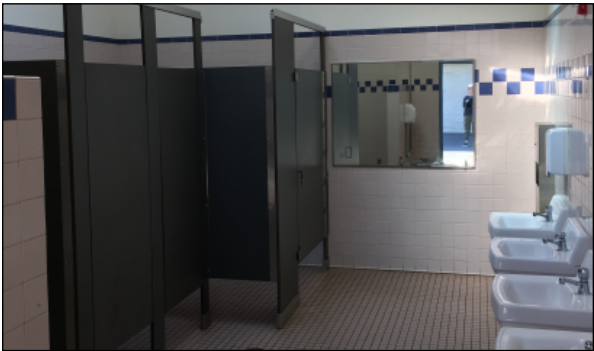
Typical Student Restroom

- Potable water is not available for the Maintenance portable on site, recommend adding access - re: hose bibs and staff restrooms.
  - Typical student and staff restrooms appear to have had ADA upgrades and meet accessible codes of that time. Due to code changes they will most likely need some upgrades if future work is to be done at existing buildings.
