# EXISTING SITE CONDITIONS

## PARK DALE LANE ELEMENTARY

Encinitas Union School District  
Facilities Plan Update

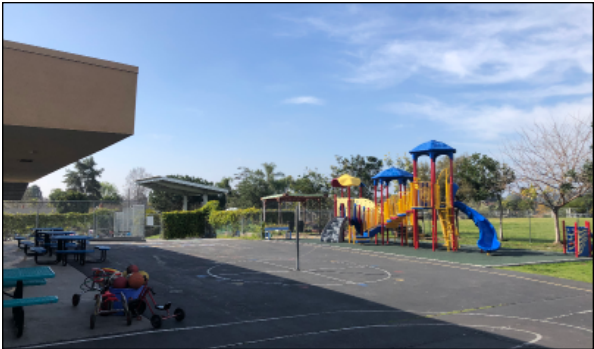
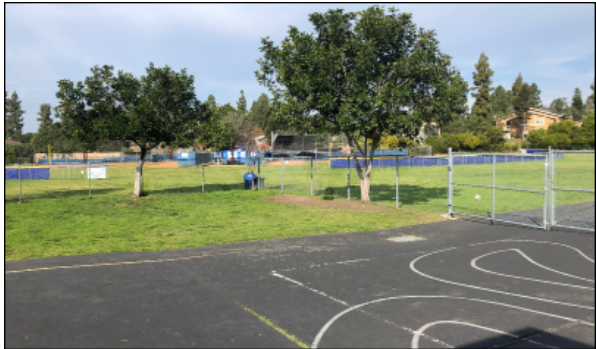
Kindergarten Play Area

- The play equipment at (2) north play yards are in fair condition.
- The Kindergarten play equipment is in good condition and includes rubberized surfacing.
- Replace fiber chips in fall zone with rubberized surfacing at the (2) north play areas.
- Ball walls are in good condition.
- Swings are in good condition, replace fiber chips with rubber.
- Basketball goals and posts are in good condition.
- Baseball fields are utilized by local sports groups. Potential replacement of backstops.

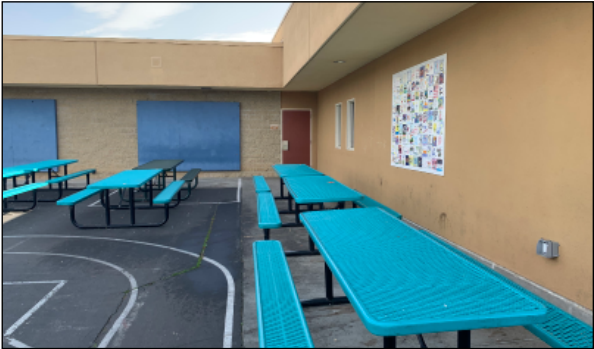
Kindergarten Lunch Area

- Modernized and more flexible Media Center
- Expand the kinder play area into the grass
- Provide shade at the Kindergarten lunch area (located at the hardcourts).
- Provide dedicated outdoor learning spaces
- Improve existing running track
- Administration office has difficult sightlines that would greatly benefit from better angles
- Inability to control the HVAC at the site. Note there is a central plant on-site that is controlled by the District. The east modular building has separate, individual units that are site-controlled.
- Supervision concerns limit the use of the outdoor play fields.

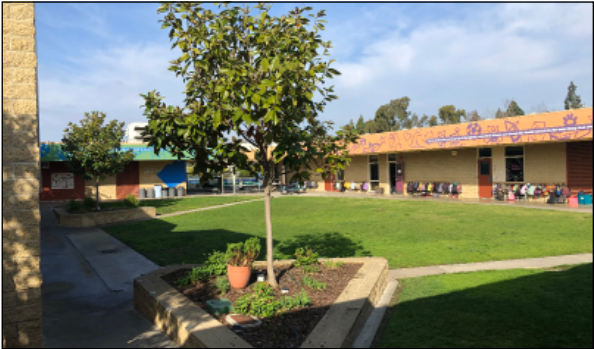
Campus Quad

Park Dale Lane Elementary includes (5) main classroom and support buildings, with (2) classroom portables situated towards the SE edge of the site. The extensive field area wraps the West and North edge of the site, as do the adjacent hardcourts. The central quad/outdoor amphitheater area is centrally relocated, but is often shaded by the adjacent Media Center to the south.

- Concrete (natural gray) and brick pavers.
- Concrete paving is in good condition at Kindergarten play and campus quad.

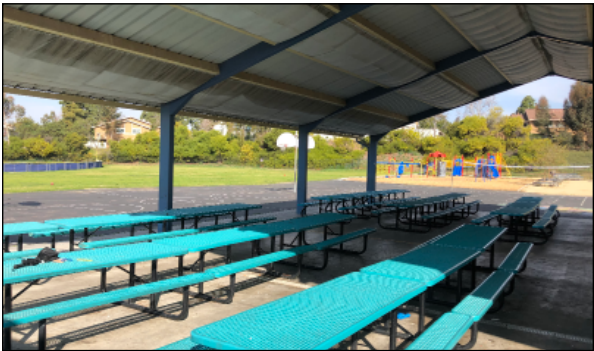
Lunch Shelter

- Repaint lunch shelter.
- Lunch shelter acoustics are not ideal, recommend addressing this in future work.
- Track is DG/grass - replace with rubberized surfacing.
- Dedicated outdoor learning spaces were requested.

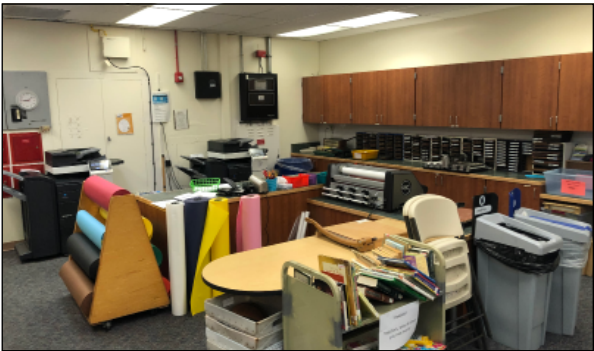
Staff Workroom

- Undersized classrooms
- Additional collaboration space for staff
- An expanded, separate staff lounge would be preferred, staff lounge and workroom should be separated

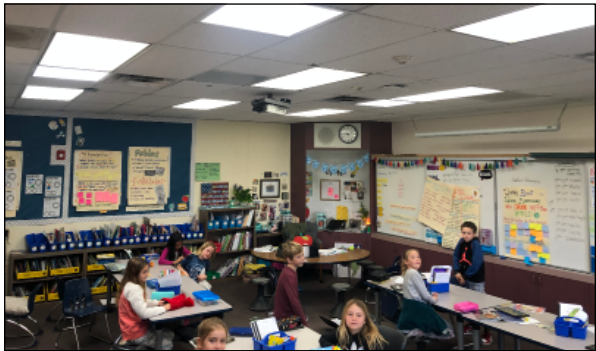
Typical Classroom

- In general, the interior finishes (flooring, painting and whiteboards) are dated and could use an update. Appropriate floor finishes for Yoga, Art, STEAM, and Nutrition Lab should be provided (i.e. resilient flooring or similar).
- Casework is in acceptable condition but could use an update.
- Classroom ceilings are ACT-type; tiles are dated or damaged and should be replaced when future work is completed in these areas.

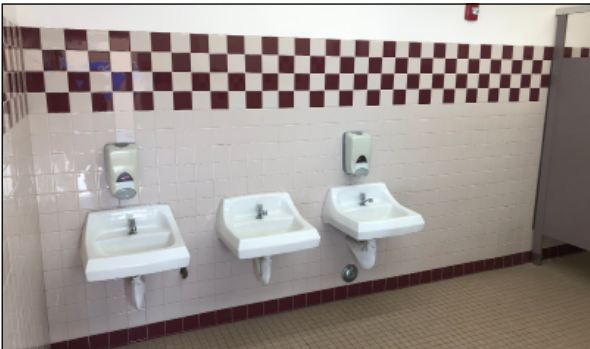
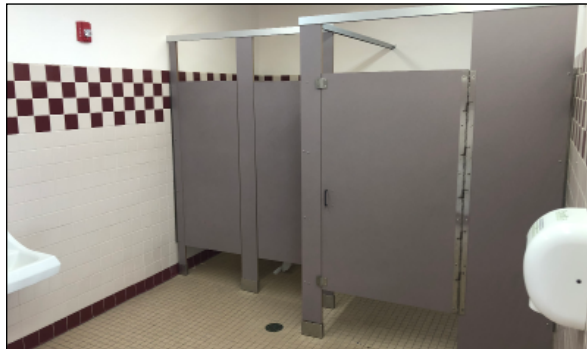
Typical Student Restroom

- Restrooms have had previous ADA upgrades.
- Classroom sinks and casework have had ADA

- Category [1]
- Plumbing piping at original buildings 200, 300, and the Admin/Media Center building is understood to be original to the 1975 construction and should be replaced.
  - Typical student and staff restrooms appear to have had ADA upgrades and meet accessible codes of that time. Due to code changes they will most likely need some upgrades if future work is to be done at existing buildings.
