# SITE FUNCTIONALITY ASSESSMENT **SUNNYVALE MIDDLE SCHOOL**

SUNNYVALE SCHOOL DISTRICT | FACILITIES MASTER PLAN **2022**

# FACILITY CONDITION ASSESSMENT

Sunnyvale Middle School  
1080 Mango Avenue  
Sunnyvale, California 94087

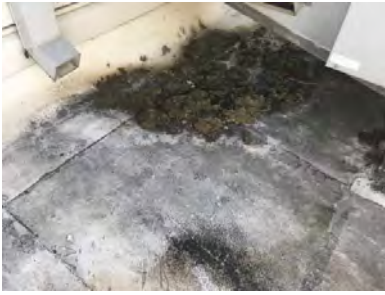
### Roofing in Poor condition.

Single-Ply Membrane, TPO/PVC  
Classrooms G1-G5 Sunnyvale Middle School  
Roof

There were lots of areas with water ponding. Also the slope of the roof is not pitched correctly causing water to not drain correctly. Signs of moss growth observed. - AssetCALC ID: 2004654

Uniformat Code: B3015  
Recommendation: **Replace in 2021**

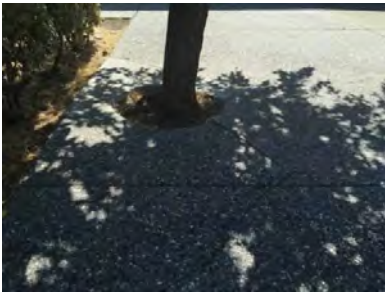
### Sidewalk in Poor condition.

any pavement type, Sectional Repairs (per  
Man-Day)  
Site Sunnyvale Middle School Near B6

Flatten the sidewalk which has been uplifted due to tree roots. - AssetCALC ID: 2004803

Uniformat Code: G2031  
Recommendation: **Repair in 2021**

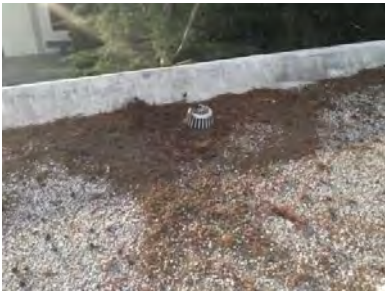
### Supplemental Components in Poor condition.

Drains, Roof, 2 IN  
Classrooms D1-D6 Sunnyvale Middle School  
Roof

Clean up roof drain and replace if needed. - AssetCALC ID: 2004575

Uniformat Code: D2032  
Recommendation: **Replace in 2021**

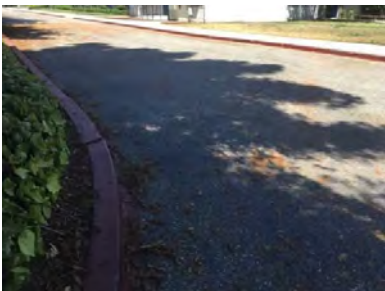
### Parking Lots in Poor condition.

Pavement, Asphalt  
Site Sunnyvale Middle School Roadway entry

The overgrown roots from the tree are causing the asphalt to be not level. It has also affected the sewer piping connected to Building B. - AssetCALC ID: 2004809

Uniformat Code: G2021  
Recommendation: **Repair in 2021**

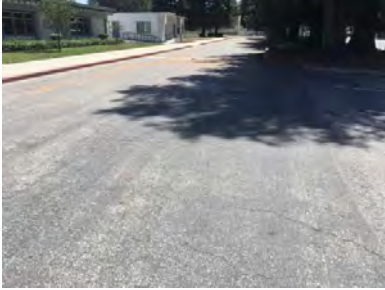
### Parking Lots in Poor condition.

Pavement, Asphalt  
Site Sunnyvale Middle School Parking lot

Alligator cracking in asphalt - AssetCALC ID: 2004802

Uniformat Code: G2021  
Recommendation: **Mill & Overlay in 2022**

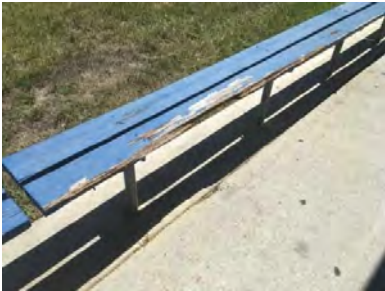
### Park Bench in Poor condition.

Wood  
Site Sunnyvale Middle School Site

Some of the benches are damaged and will need replaced. - AssetCALC ID: 2004814

Uniformat Code: G2062  
Recommendation: **Replace in 2021**

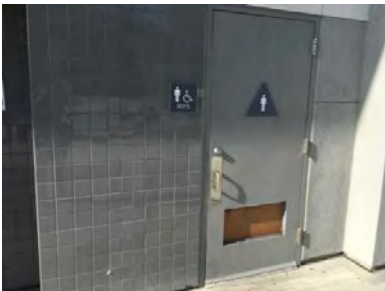
### Louvers in Poor condition.

Windows throughout the site are double-paned, aluminum framed. The exterior louver for the Building G restroom doors are damaged and need to be replaced.

Aluminum  
Classrooms G1-G5 Sunnyvale Middle School  
Building exterior

Missing Louvers on the restroom door. - AssetCALC ID: 2004664

Uniformat Code: B2071  
Recommendation: **Replace in 2021**

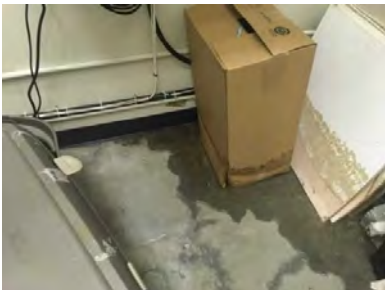
### HVAC Steam Components in Poor condition.

Pump, Condensate Water Return, 3 HP  
Classrooms G1-G5 Sunnyvale Middle School  
Mechanical room

Condensate pump failure has cause water leak. - AssetCALC ID: 2004658

Uniformat Code: D3053  
Recommendation: **Replace in 2021**

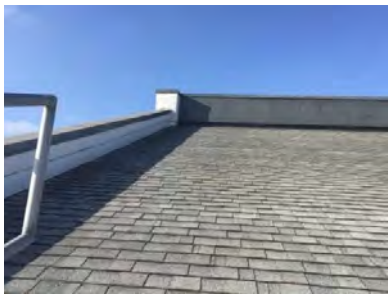
### Roof Appurtenances

Roof Access Ladder, Steel  
Multipurpose/Classrooms F1-F3 Sunnyvale  
Middle School Roof

Uniformat Code: B3021  
Recommendation: **Install in 2021**
