**DISTRICTWIDE FACILITIES ASSESSMENT 2022**  
WOODLAND JOINT UNIFIED SCHOOL DISTRICT

SITE PACKAGE  
**SCI TECH CHARTER ELEMENTARY**

# FACILITY CONDITION ASSESSMENT

Sci Tech Charter  
9544 Mill Street  
Knights Landing, California 95645

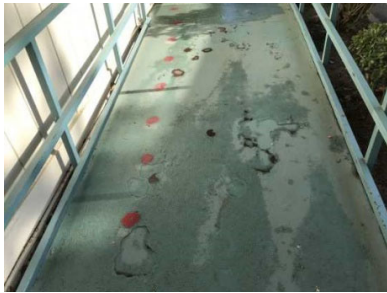
### Exterior Ramp in Poor condition.

Wood  
Site Sci Tech Charter Site, portable 5

The ramp surface is deteriorated and potentially a slip hazard. - AssetCALC ID: 2971151

Uniformat Code: B1012  
Recommendation: **Replace in 2021**

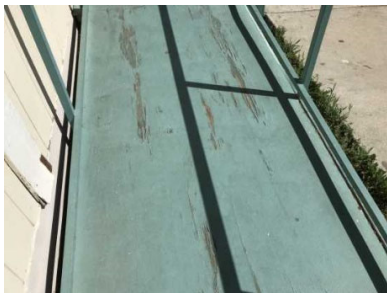
### Exterior Ramp in Poor condition.

Wood  
Site Sci Tech Charter Site, portables 14-16

The plywood ramps are weather damaged. - AssetCALC ID: 2971165

Uniformat Code: B1012  
Recommendation: **Replace in 2021**

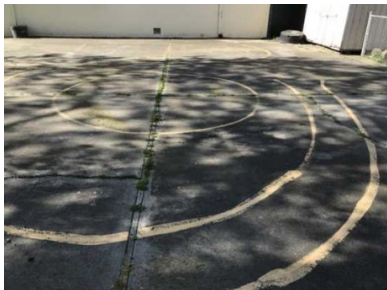
### Athletic Surfaces & Courts in Poor condition.

Basketball/General, Asphalt Pavement  
Site Sci Tech Charter Site, behind buildings 1, 2-4

The playground behind classes 1-4 are significantly cracked. - AssetCALC ID: 2971069

Uniformat Code: G2051  
Recommendation: **Mill & Overlay in 2021**

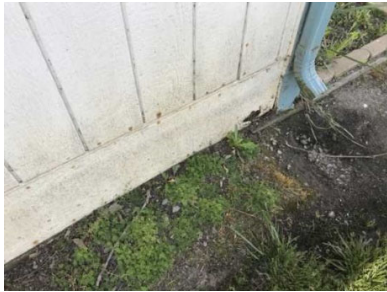
### Exterior Walls in Poor condition.

Textured T1-11  
Portable Classroom 10 Sci Tech Charter  
Building exterior

There are areas of dry rot and weather damage. - AssetCALC ID: 2980061

Uniformat Code: B2011  
Recommendation: **Replace in 2021**

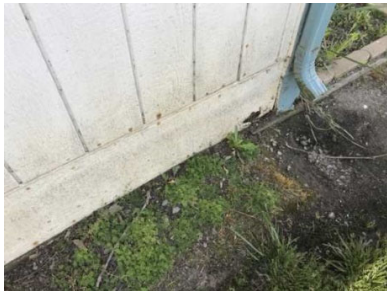
### Exterior Walls in Poor condition.

any painted surface, 1-2 Story Building  
Portable Classroom 10 Sci Tech Charter  
Building exterior

The building requires paint with new T1-11. - AssetCALC ID: 2971096

Uniformat Code: B2011  
Recommendation: **Prep & Paint in 2021**

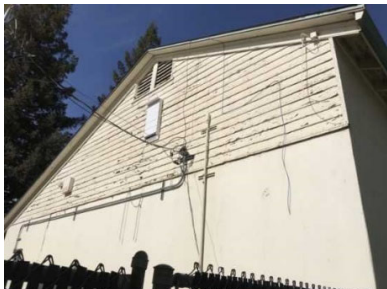
### Exterior Walls in Poor condition.

any painted surface, 1-2 Story Building  
Classrooms 2-4 Sci Tech Charter Building  
exterior

The exterior paint is significantly peeling with stucco cracks that require sealing and overall repaint. - AssetCALC ID: 2971026

Uniformat Code: B2011  
Recommendation: **Prep & Paint in 2021**

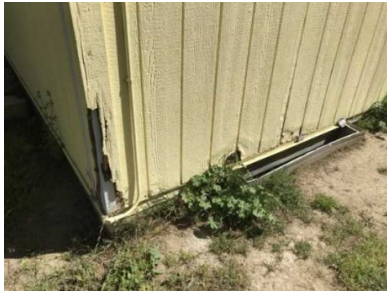
### Exterior Walls in Poor condition.

Textured Plywood (T1-11)  
Family Resource Center Sci Tech Charter  
Building exterior

Exterior siding exhibits dry rot and is approaching end of its EUL. - AssetCALC ID: 2972388

Uniformat Code: B2011  
Recommendation: **Replace in 2022**

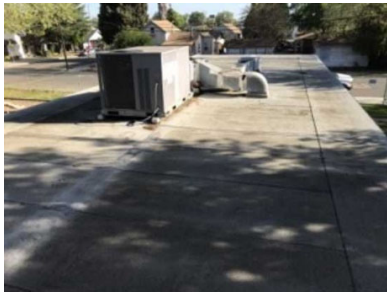
### Roofing in Poor condition.

Modified Bitumen  
Portable Classrooms 6-9 Sci Tech Charter Roof

The roof has had previous leaks with multiple patches and appears to be well past its EUL. - AssetCALC ID: 2971054

Uniformat Code: B3015  
Recommendation: **Replace in 2021**

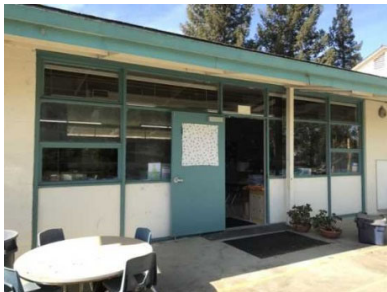
### Storefront in Poor condition.

Glazing & Framing  
Classroom 1 Sci Tech Charter Building exterior

The windows are single pane, energy inefficient and well past their expected useful life. - AssetCALC ID: 2971050

Uniformat Code: B2023  
Recommendation: **Replace in 2022**

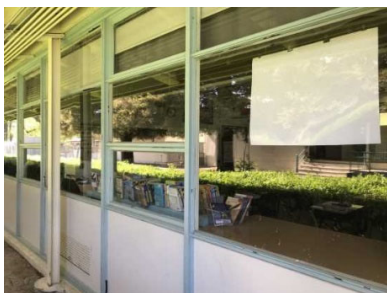
### Storefront in Poor condition.

Glazing & Framing  
Classrooms 11-13 Sci Tech Charter Building  
exterior

The exterior windows are single pane, energy inefficient and well past their expected useful life. - AssetCALC ID: 2971146

Uniformat Code: B2023  
Recommendation: **Replace in 2022**

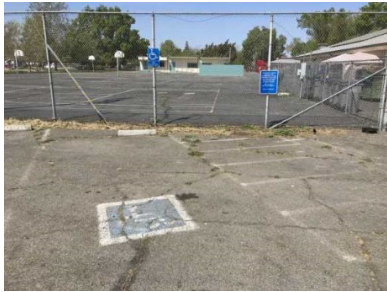
### Parking Lots in Poor condition.

Pavement, Asphalt  
Site Sci Tech Charter Site, Mill Street

The asphalt paving on Mill Street is reportedly maintained by the school district and is significantly worn, with multiple patches and uneven surfaces. - AssetCALC ID: 2971143

Uniformat Code: G2021  
Recommendation: **Mill & Overlay in 2021**

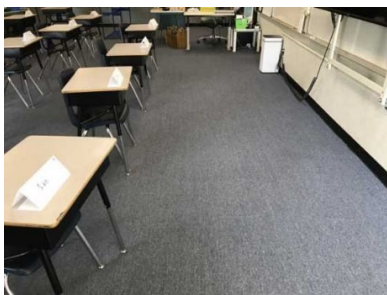
### Flooring in Poor condition.

Carpet, Commercial Standard  
Portable Classrooms 14-16 Sci Tech Charter  
Portable 14

The carpet has open seams and stains. - AssetCALC ID: 2971132

Uniformat Code: C2037  
Recommendation: **Replace in 2021**

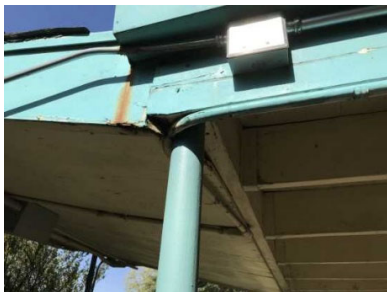
### Shed/Gazebo/Shade Structure in Poor condition.

Wood or Metal-Framed, Standard  
Site Sci Tech Charter Covered walkways, north

The north walkway structure exhibits significant rot and deterioration. - AssetCALC ID: 2971008

Uniformat Code: F1024  
Recommendation: **Replace in 2021**

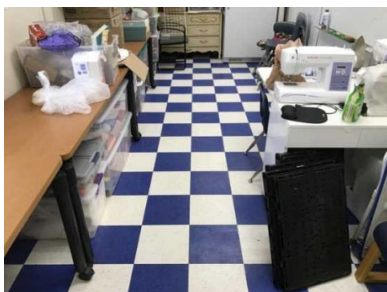
### Flooring in Poor condition.

Vinyl Tile (VCT)  
Family Resource Center Sci Tech Charter  
Throughout

Flooring is mismatched with cracks and broken areas. - AssetCALC ID: 2972389

Uniformat Code: C2035  
Recommendation: **Replace in 2021**

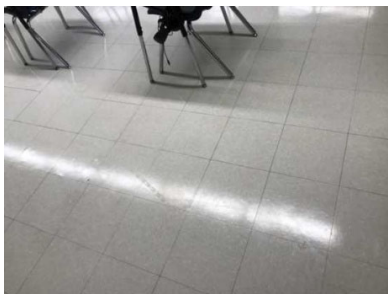
**Flooring in Poor condition.**

Vinyl Tile (VCT)  
Classrooms 11-13 Sci Tech Charter Classroom  
13

Uniformat Code: C2035  
Recommendation: **Replace in 2022**
