**DISTRICTWIDE FACILITIES ASSESSMENT 2022**  
WOODLAND UNIFIED SCHOOL DISTRICT

SITE PACKAGE  
**CE DINGLE ELEMENTARY**

# FACILITY CONDITION ASSESSMENT

Dingle Elementary  
625 Elm Street  
Woodland, California 95695

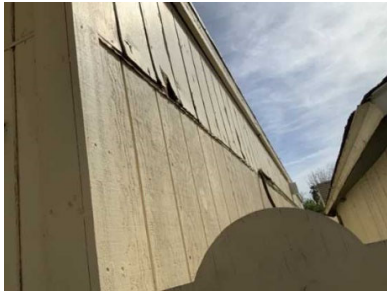
### Exterior Walls in Failed condition.

Textured Plywood (T1-11)  
Portables Group 1 Dingle Elementary Modular  
1

Rotted, warped and delaminated boards in limited locations. - AssetCALC ID: 2979094

Uniformat Code: B2011  
Recommendation: **Replace in 2021**

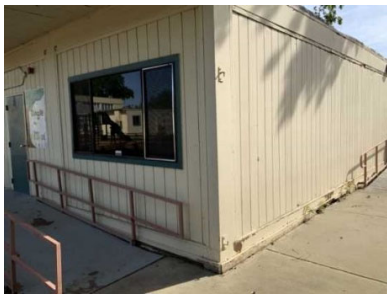
### Exterior Walls in Failed condition.

Plywood/OSB  
Portables Group 2 Dingle Elementary Modular  
campus

Rotted boards - AssetCALC ID: 2979106

Uniformat Code: B2011  
Recommendation: **Replace in 2021**

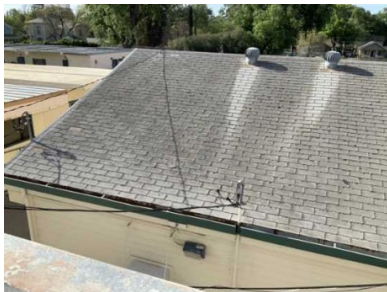
### Roofing in Poor condition.

Asphalt Shingle, 20-Year Standard  
Staff Building Dingle Elementary Staff room

Loose, curling and damaged shingles throughout - AssetCALC ID: 2976242

Uniformat Code: B3011  
Recommendation: **Replace in 2021**

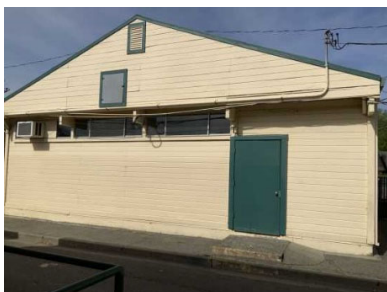
### Exterior Walls in Poor condition.

Wood Siding  
Staff Building Dingle Elementary Staff room

Warped and rotted siding throughout - AssetCALC ID: 2976220

Uniformat Code: B2011  
Recommendation: **Replace in 2021**

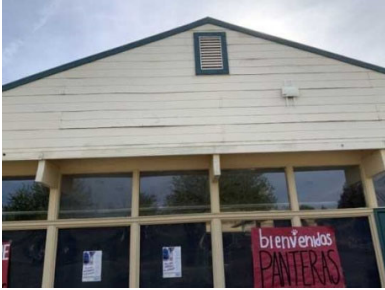
### Window in Poor condition.

Wood, 28-40 SF  
Staff Building Dingle Elementary Staff room

Plexiglass glazing - AssetCALC ID: 2976264

Uniformat Code: B2021  
Recommendation: **Replace in 2021**

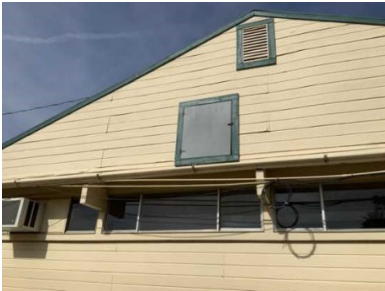
### Window in Poor condition.

Aluminum Double-Glazed, 28-40 SF  
Staff Building Dingle Elementary

Single pane glazing - AssetCALC ID: 2978933

Uniformat Code: B2021  
Recommendation: **Replace in 2021**

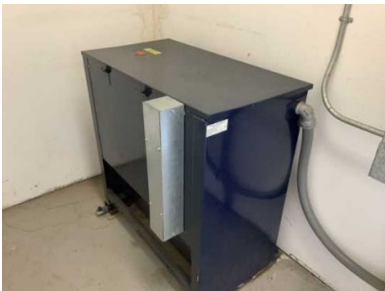
The elevator has reported reliability issues with the hydraulic pump.

### Passenger Elevator in Poor condition.

Hydraulic, 2 Floors  
Administration Building Dingle Elementary Main

Hydraulic pump is unreliable. - AssetCALC ID: 2976222

Uniformat Code: D1011  
Recommendation: **Renovate in 2023**

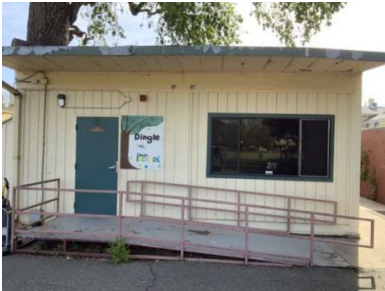
### Soffit in Poor condition.

Wood  
Portables Group 3 Dingle Elementary

Rotting, damaged - AssetCALC ID: 3002046

Uniformat Code: B3082  
Recommendation: **Replace in 2023**

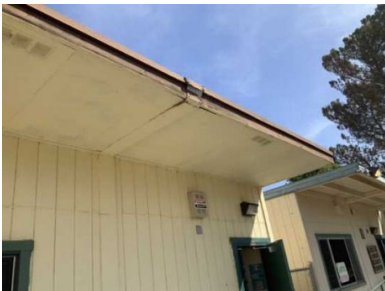
### Soffit in Poor condition.

Wood  
Portables Group 2 Dingle Elementary

Rotting, damaged - AssetCALC ID: 3002048

Uniformat Code: B3082  
Recommendation: **Replace in 2023**

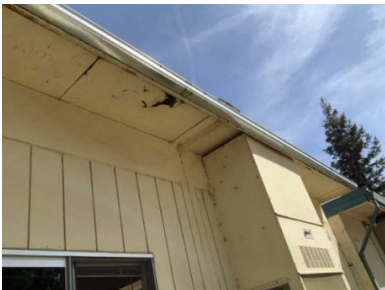
### Soffit in Poor condition.

Wood  
Portables Group 1 Dingle Elementary

Rotting, damaged - AssetCALC ID: 3002047

Uniformat Code: B3082  
Recommendation: **Replace in 2023**
