# EXISTING SITE CONDITIONS

## MISSION ESTANCIA ELEMENTARY

Encinitas Union School District  
Facilities Plan Update

3330 Calle Barcelona, Carlsbad, CA 92009

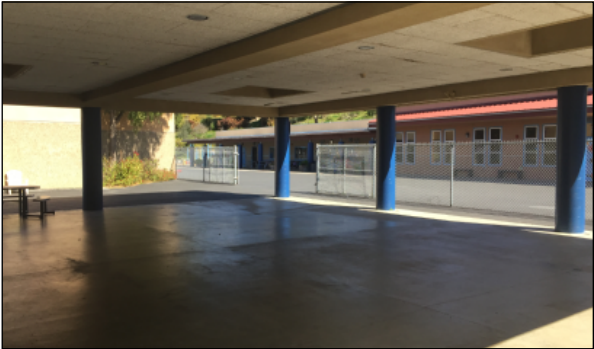
Covered Outdoor Pavilion

- Improve existing exterior open-air MPR structure.
- Track is DG/grass - Replace with rubberized surfacing.
- Dedicated outdoor learning spaces were requested.
