# EXISTING SITE CONDITIONS

## OLIVENHAIN PIONEER ELEMENTARY

Encinitas Union School District  
Facilities Plan Update

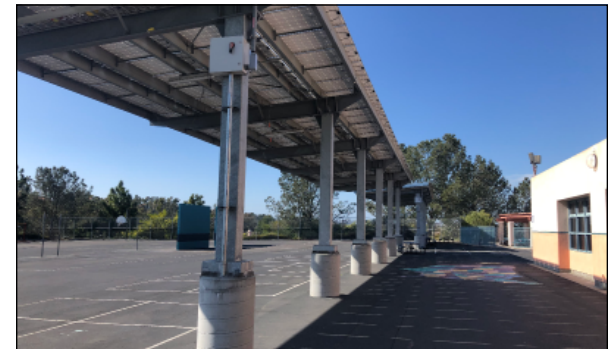
Solar Shade Structure and Hardcourts

- Hardcourts are in good condition and were last replaced in Summer 2018. Striping was also updated.
- Verify potential cross slope issues (>2%).
