**DISTRICTWIDE FACILITIES ASSESSMENT 2022**  
WOODLAND JOINT UNIFIED SCHOOL DISTRICT

SITE PACKAGE  
**PLAINFIELD ELEMENTARY**

# FACILITY CONDITION ASSESSMENT

Plainfield Elementary  
20450 County Road 97,  
Woodland, California 95695

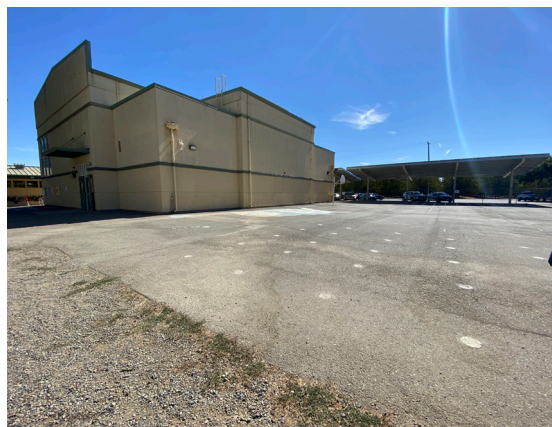
Hardcourts are in bad shape. Asphalt needs to be replaced and the hardcourt area expanded to include basketball and tether-ball. Students would also like a backstop on the field for kickball / baseball.

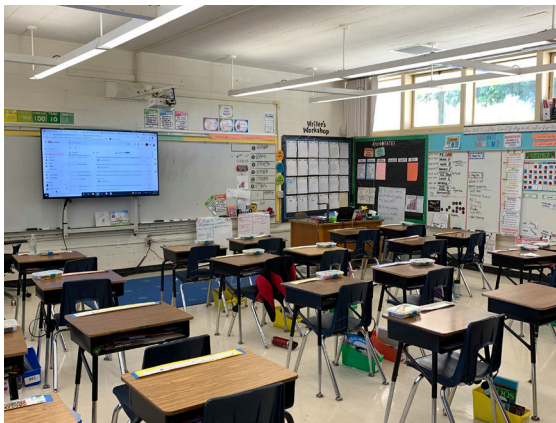
Typical Classroom

Classroom space and storage is adequate but needs to be updated. Windows are not operable or efficient and need upgraded shading systems. Finishes are outdated and deteriorating. Cinder-block construction does not allow for hanging material on the wall. Would like to have tack-boards installed. Chromebook use demands more/updated outlets in the classrooms. Currently not enough secure storage for students personal items and music instruments.

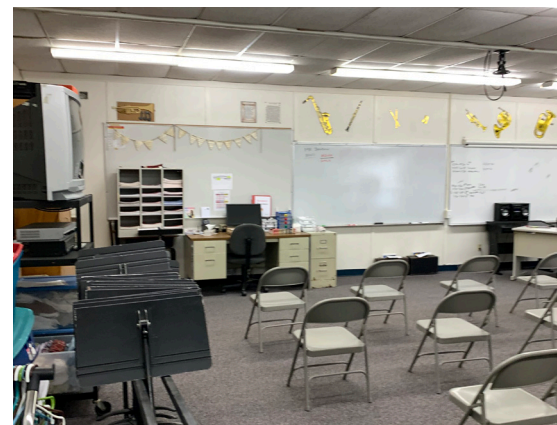
Music Room

Art is done in classrooms or outside and is accepted by students and staff. Music is noted to function well but needs an update to furniture and technology. There is also some acoustic issues with the music room causing sound to disrupt other classes and students.
